*Cougar Creek/Northeast Interceptor Canal*  
**INTEGRATED STORMWATER MANAGEMENT PLAN**  
**FINAL REPORT**

**Cougar Creek/Northeast  
Interceptor Canal  
Integrated Stormwater  
Management Plan Report**

*Project Nos.: 06-6904 and 06-6987*

#### Integrated Stormwater Management Plan – A Health Card and Executive Summary

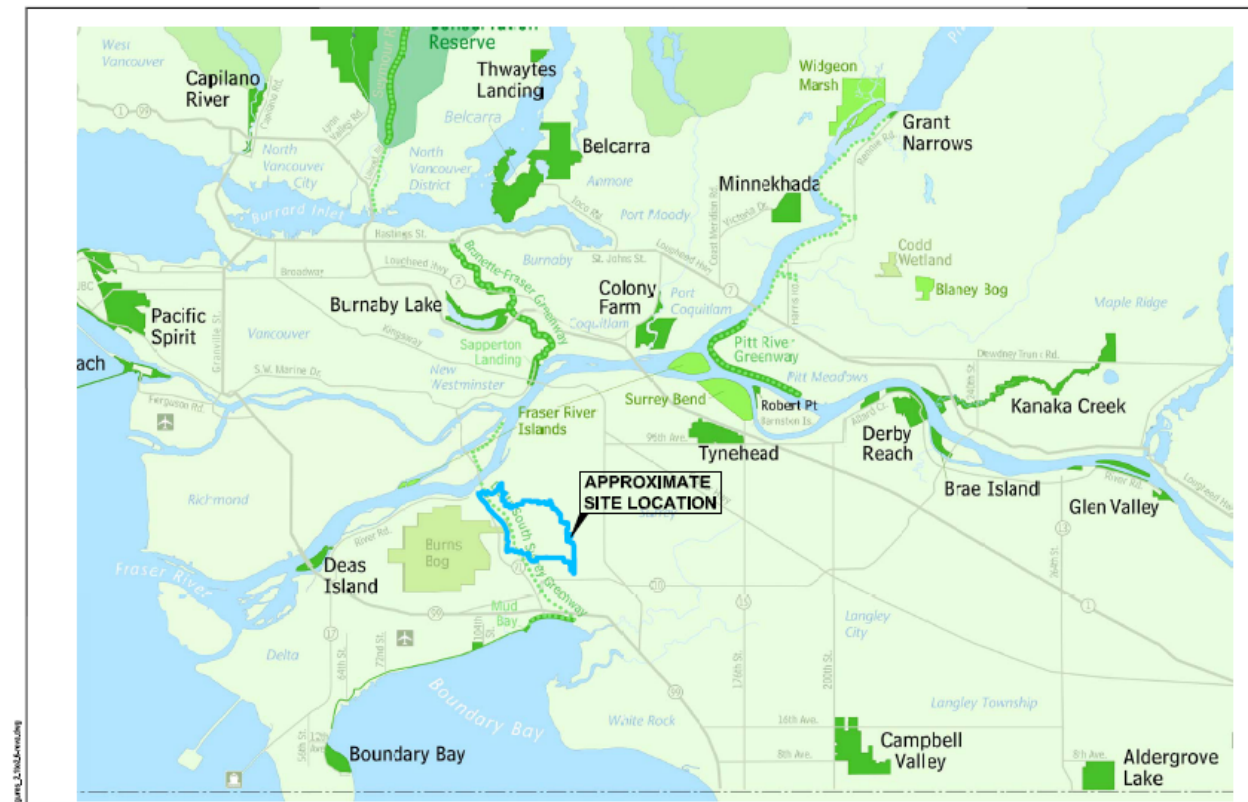
**Figure 1-1: Key Map**

The purpose of the study is to develop a comprehensive and integrated storm water management plan which will set out a sustainable strategy for storm water management in the Cougar Creek and North East Interceptor Canal watershed. A key map of the study area location is shown below in **Figure 1-1**.

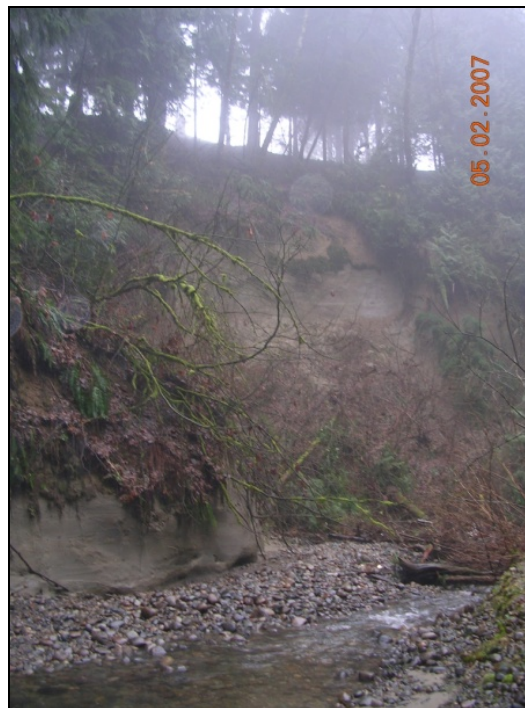
2. Undercutting and Slab Regression: This type of mass movement results from erosion at the toe of the slope and resulting failure of the oversteepened slope. Such undercutting and failure of the slope in dense sand, and sand and gravel results in small slab failures regressing up the slope at very steep slope angles. After the stream moves away from the toe of the slope, the slope ravel to a long term stable slope angle. It is often during this phase that the movement reaches the crest of the slope. There are several of these features where Cougar Creek cuts down through the erodable material, all on the left bank, between the pedestrian overpass and the elementary school at Lyon Road. This is the most common active bank feature in the valley and is a major source of sediment load for the stream.

**Photo 1: Large Slope Erosion with Houses near Slope Crest, an Example of Undercutting and Slab Regression.**

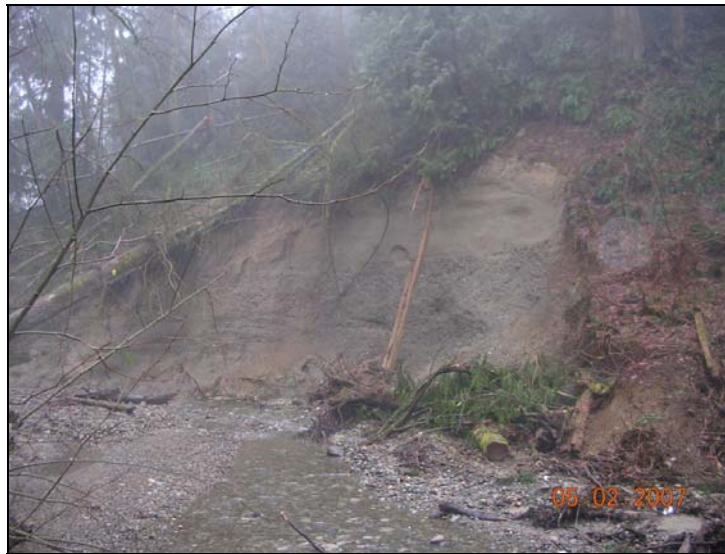
**Photo 2: The Largest Eroded Slope in Cougar Canyon, an Example of Undercutting and Slab Regression**

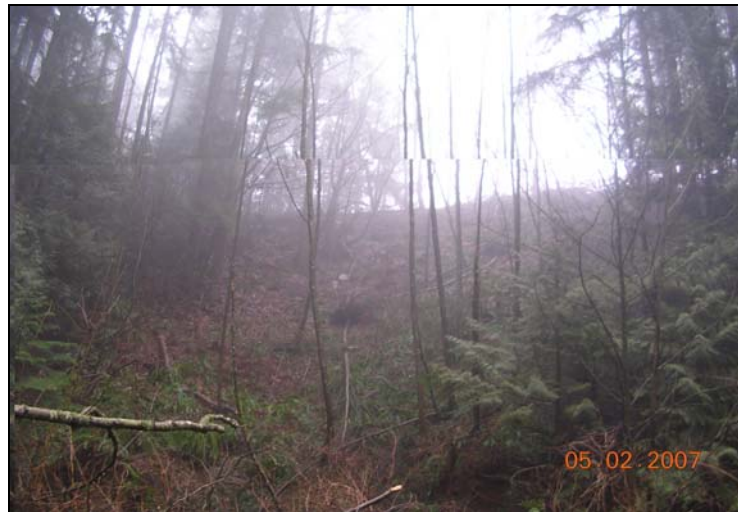
Some fills were noted in both Surrey and Delta, but in areas where the Canyon was relatively shallow. In these areas, the greatest threat is temporary stream blockage as a result of fill failure. Little risk to structures is anticipated. The presence of fill at slope crests was not investigated during the field traverse in the deeper sections of the Canyon due to both time constraints and property access rights. It is probable that several lots will have fills, as that would have been a normal practise.

**Photo 3: Probable Area of Fill Placement on North Bank**

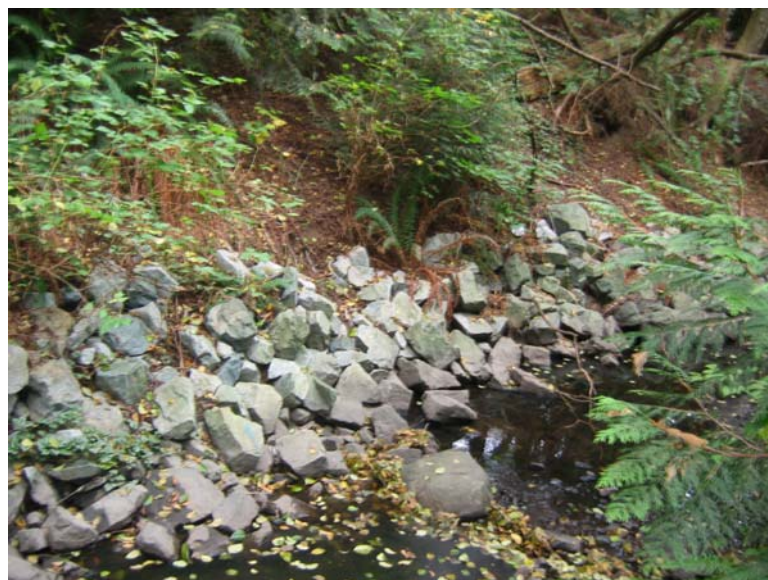
**Photo 4: Example of Area of Terrace Instability with Stabilization Works**

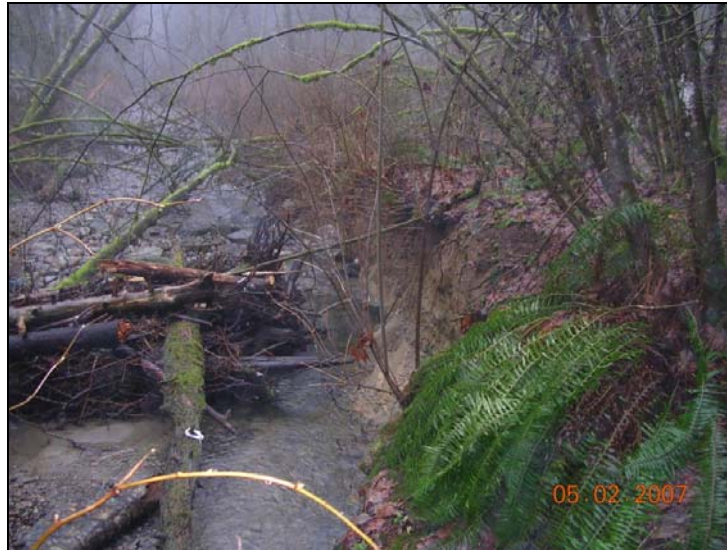
6. ***Bank and Bed Erosion:*** At several sites downstream of Nicholson Road, Cougar Creek appears to be slowly downcutting. The erosion activity may be related to climate and/or development that increases peak stream flows. This activity generally contributes sediment to the stream bed. In addition, related stream bank erosion provides additional sediment source. Where stream bank erosion impacts Canyon slopes, slope instabilities as noted in point 3, above is observed.

**Photo 5: Erosion into Terrace on Right Bank**

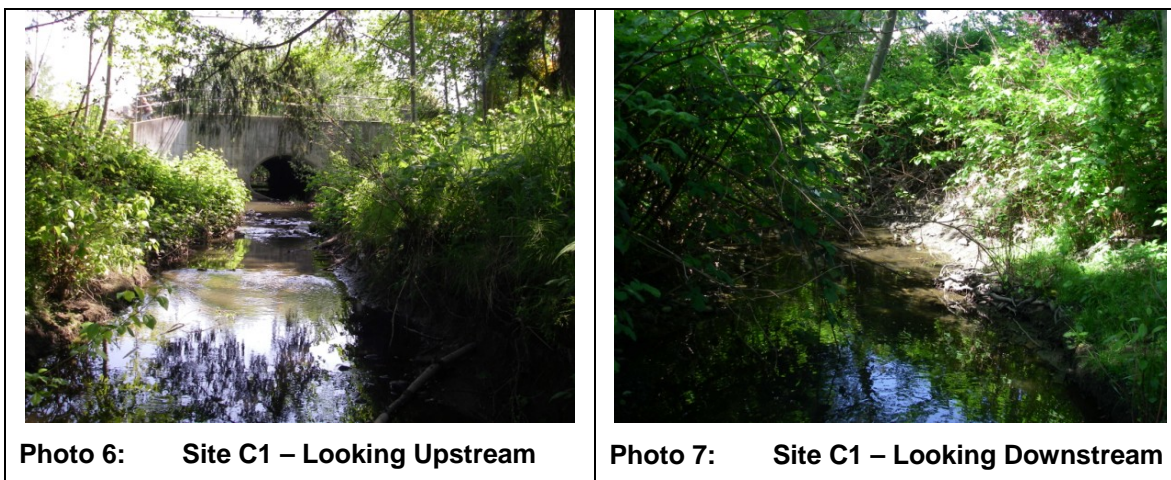
Cougar Creek immediately west of 120<sup>th</sup> Street is a linear channel with low flow generally observed in the spring sampling season. The channel exhibited a wetted width of ~2.5m and a bankfull width of ~3m. Average water depth at the time of sampling was 5-10cm. The substrate consisted of hardpan clay with a short section of gravel. Garbage was observed within the creek at this location. The water was slightly turbid at the time of sampling and a high level of algae was observed. Riparian vegetation in the area consisted of manicured vegetation and shrubs on the north (right) bank, and shrubs and mature trees on the south (left) bank (**Photographs 6 and 7**).

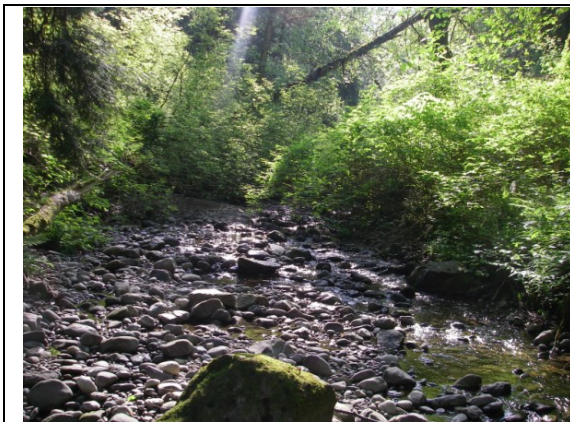
Photo 8: Site CC2 – Looking Upstream

The 'middle' sample site was located within a deep ravine with extensive and established riparian vegetation on both sides of the creek (**Photographs 8 and 9**). The creek at this location exhibited run/riffle/pool complexes, with large boulders and large woody debris. Wetted width ranged from 2-6m, with a bankfull width of 8-12m. Water depth was ~10cm at the time of sampling. The substrate was clean, ~80% embedded, and consisted of boulders, cobble and coarse gravel.

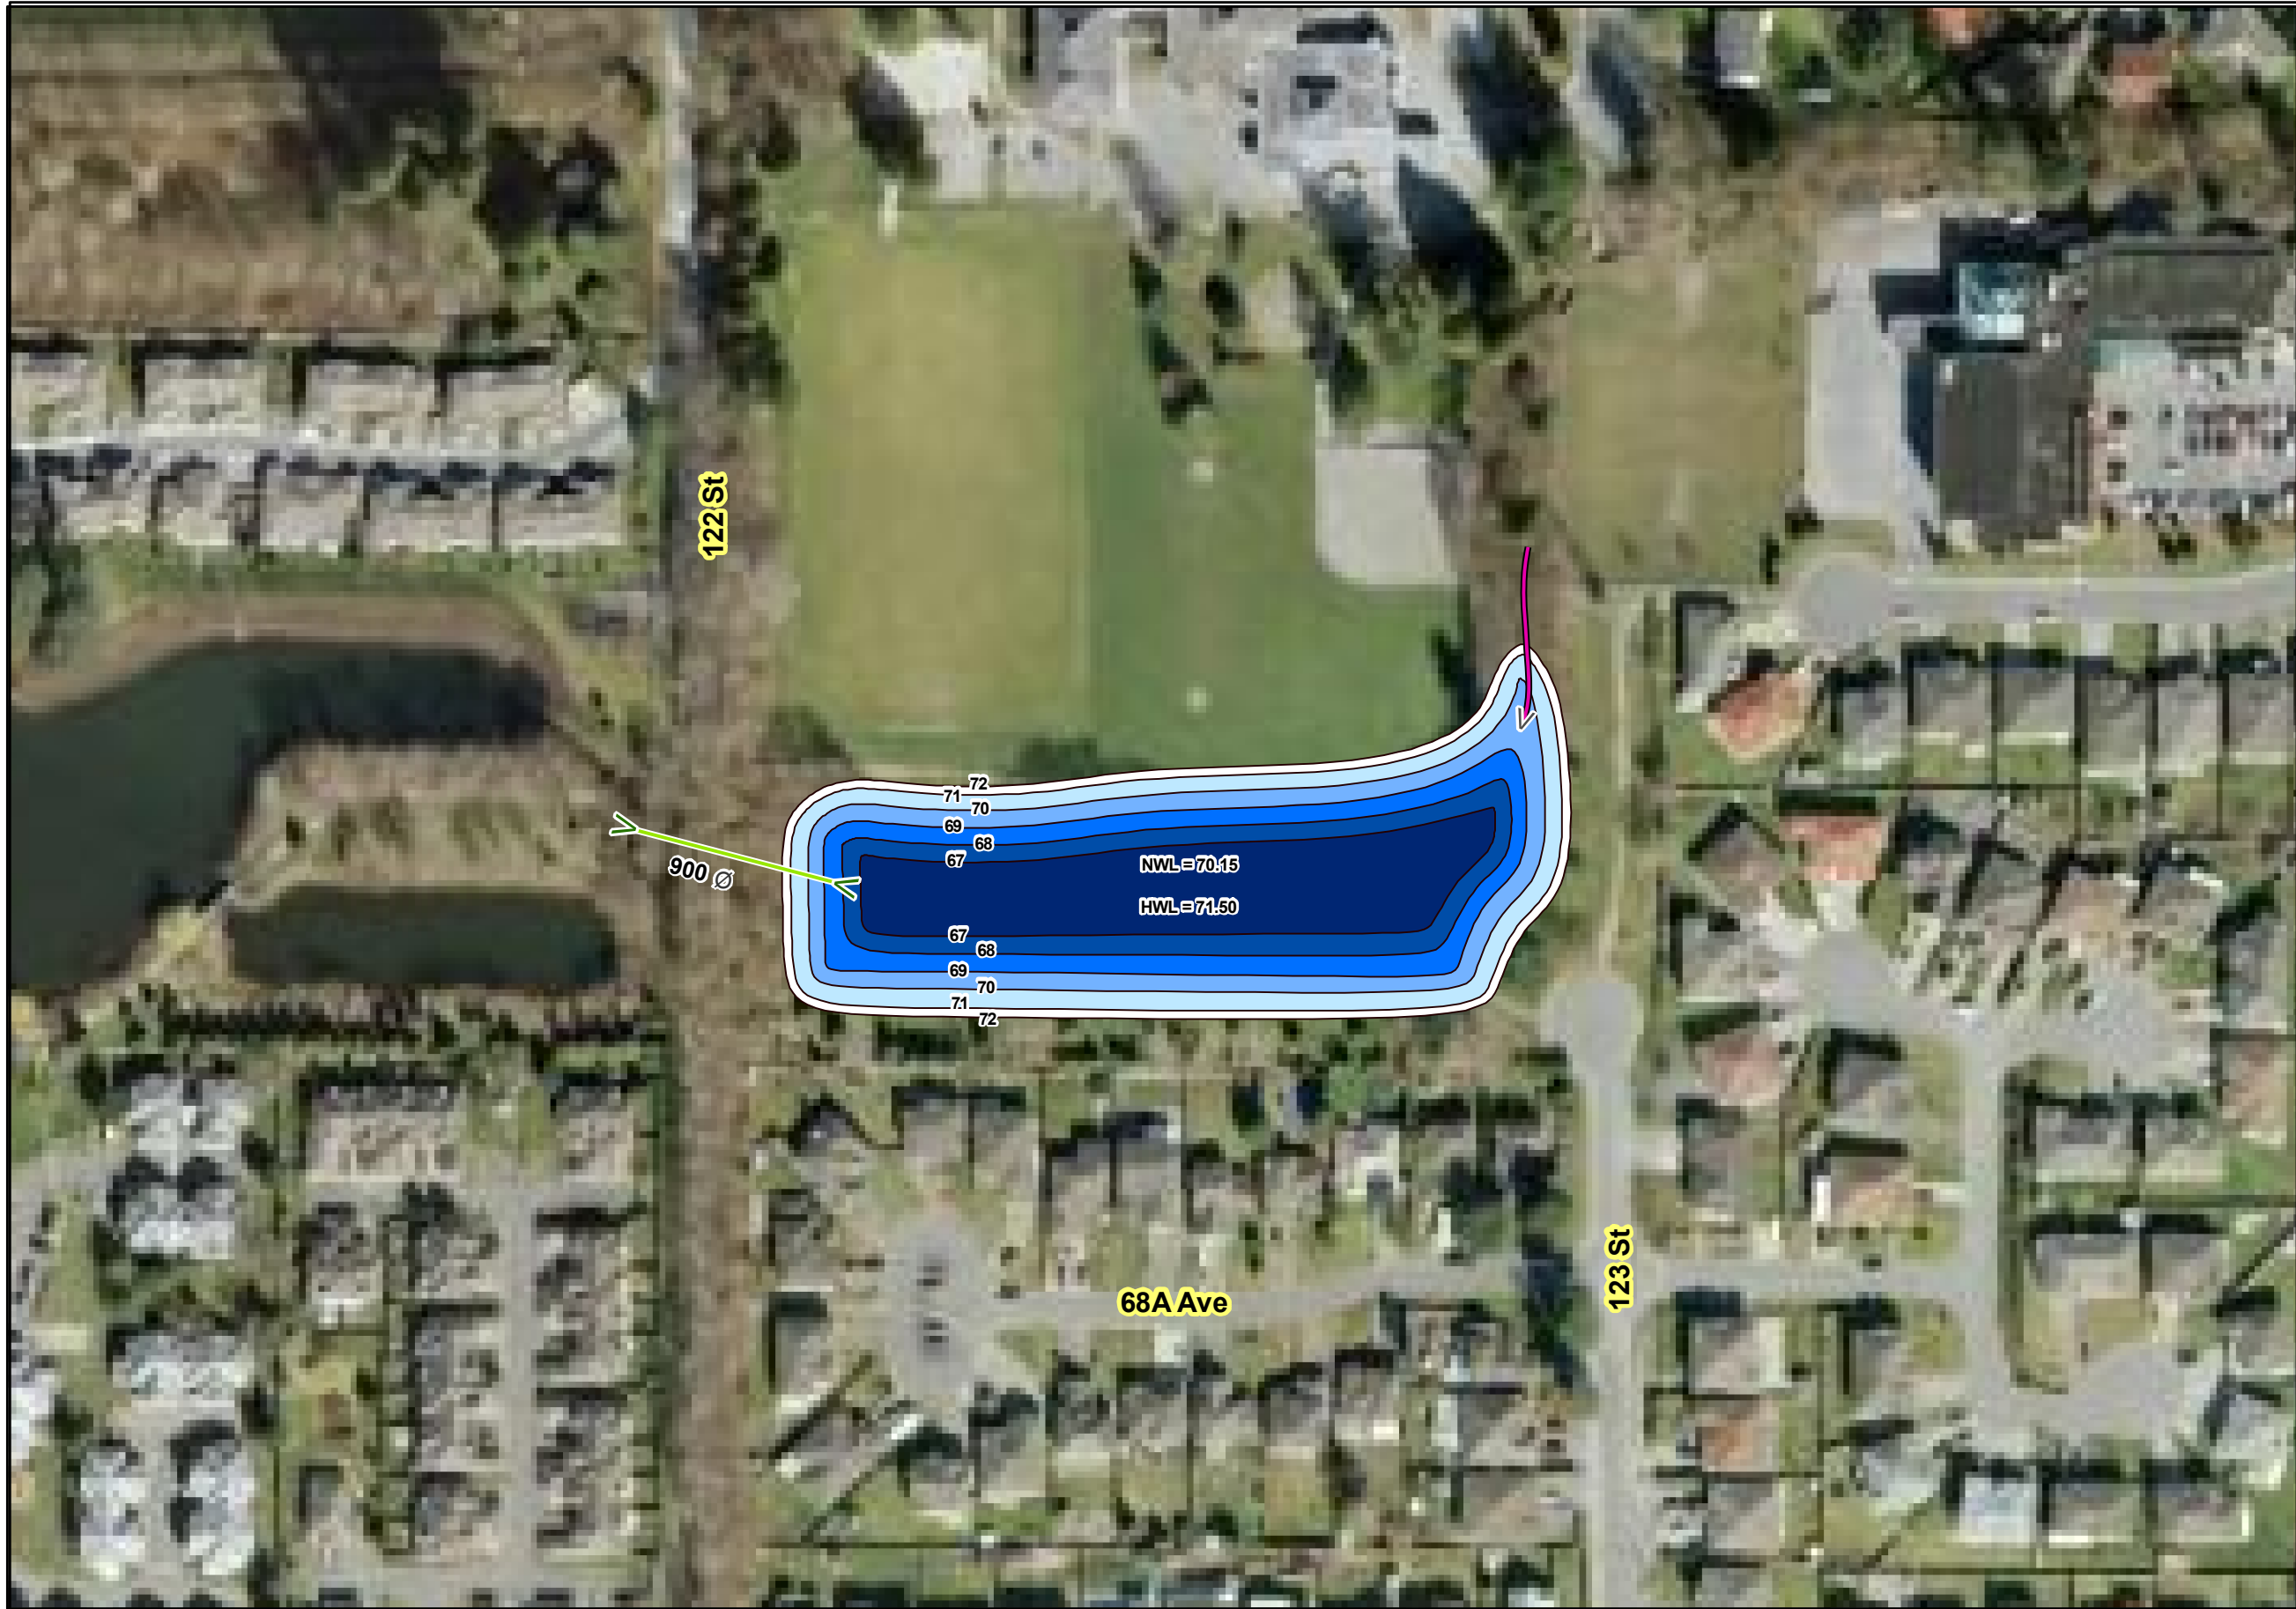
The Cougar Creek Park Pond was assumed to expand into the area to the east and south of the existing soccer pitch where the existing creek channel currently runs (See **Figure 4-4**, **Figure 4-5** and **Figure 4-6**). These two ponds would be hydraulically connected by a submerged culvert under 122<sup>nd</sup> Street. The available space for wet pond construction was restricted in efforts to minimize impacts to the existing playing fields. The existing pathway to the north of the creek would require replacement. Design elevations were based on the existing pond. Stage-area-storage-discharge relationships for the existing facilities were derived from as-built drawings available from the City.

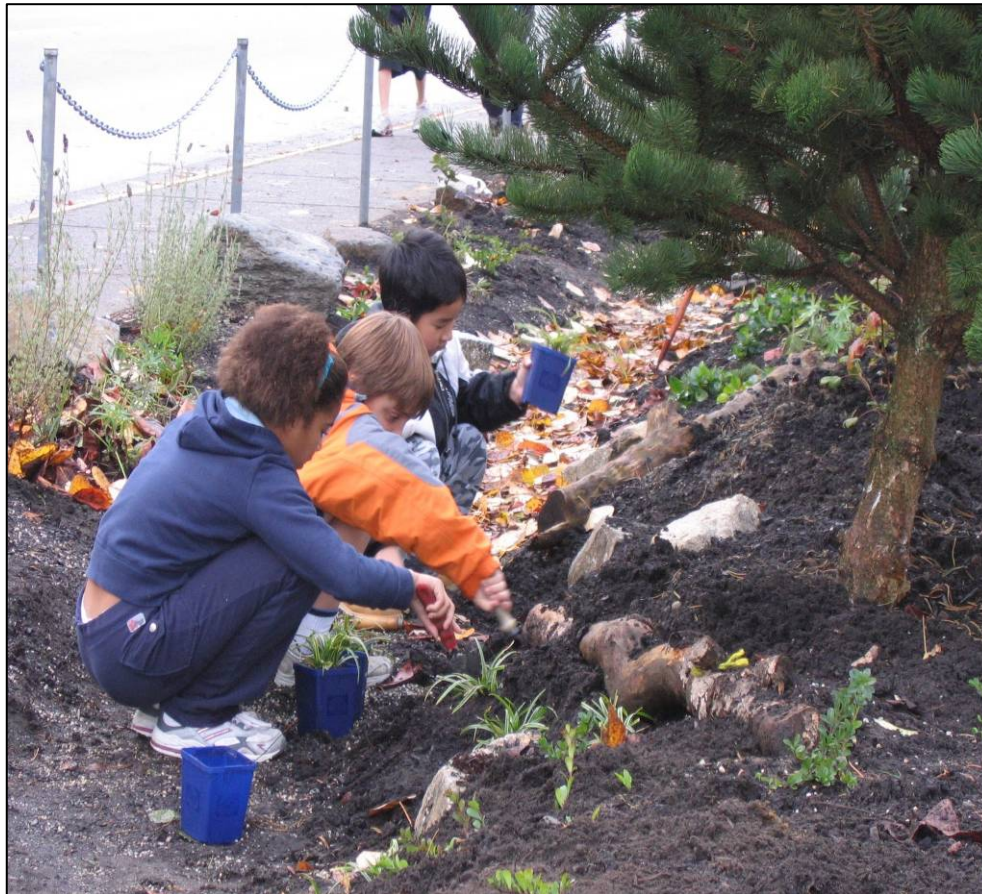
**Photo 12: Cougar Canyon Elementary School Raingarden**
