# ENVIRONMENTAL STUDY REPORT

Northwest Whalley Infill Concept Plan Area  
Surrey, B.C.

City of Surrey  
Community Planning Division  
Planning & Development Services

PHOENIX ENVIRONMENTAL SERVICES LTD.

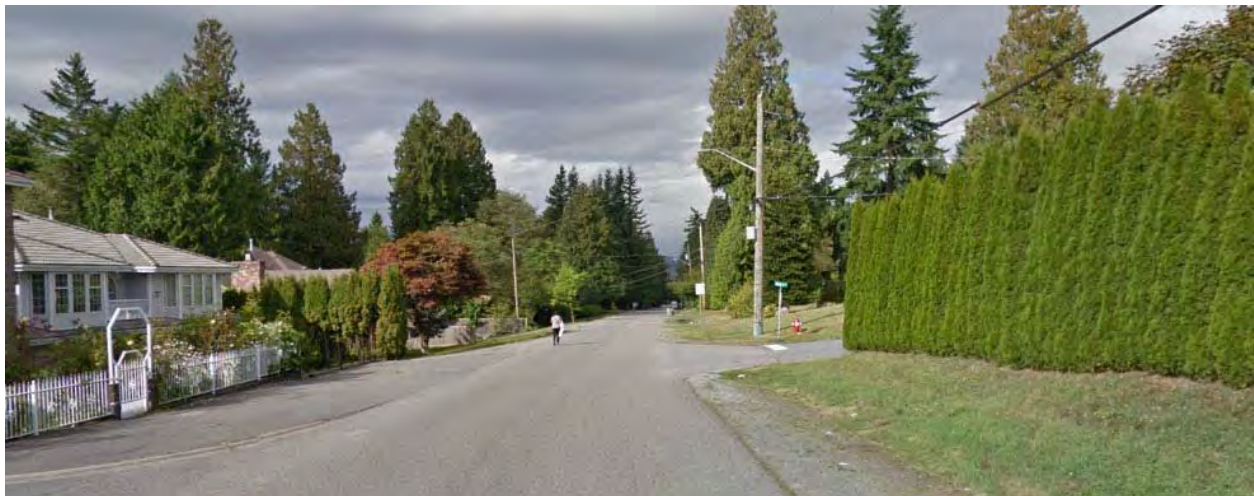
View looking North down 127<sup>th</sup> Street from near the intersection with 104<sup>th</sup> Avenue.

The character of the Northwest Whalley neighbourhood is intricately tied to the existing vegetation not only from the key viewpoints to the north of the neighbourhood, but also from within it. Two typical examples of the character are shown in the photos below. In each, the vegetation dominates the view, and only one or two homes are visible, even from a close distance.

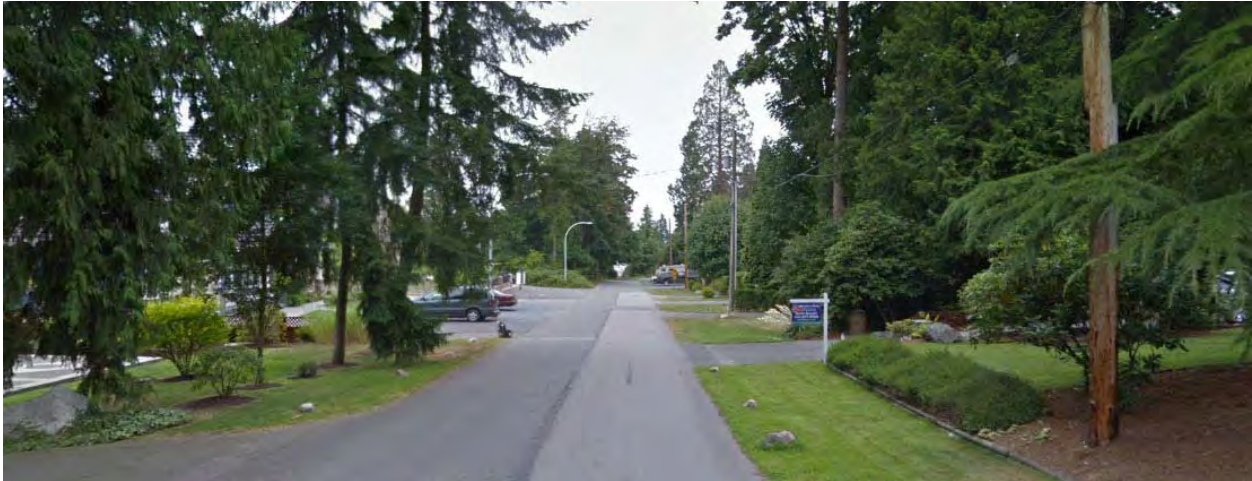
View looking North down 127<sup>th</sup> Street from near the centre of the neighbourhood.

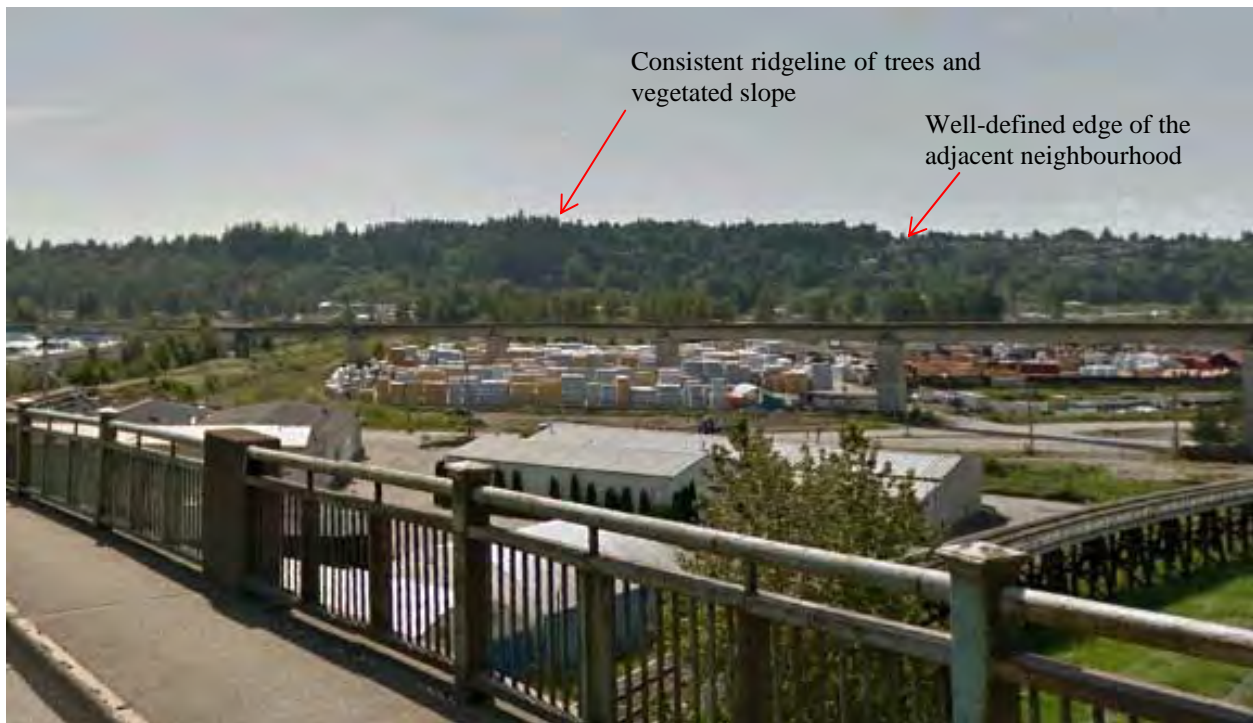
View from the Pattullo Bridge

The journey across the river by automobile or SkyTrain offers the most prominent views of the neighbourhood due to the elevation and the direct line of both bridges toward the southeast with the neighbourhood visible straight ahead or just to the right. A large number of people travel across the river daily. The portion of the journey where the neighbourhood is visible is relatively short (about 1 minute), but the predominant forest character of the view from both bridges remains distinctive relative to surrounding areas. Extensive clearing of the existing forested slopes would certainly be noticed.

To mitigate changes to the view, retention of most of the mature trees along the ridge, over the escarpment slope, and the west and north perimeter of the ICP area should be considered.

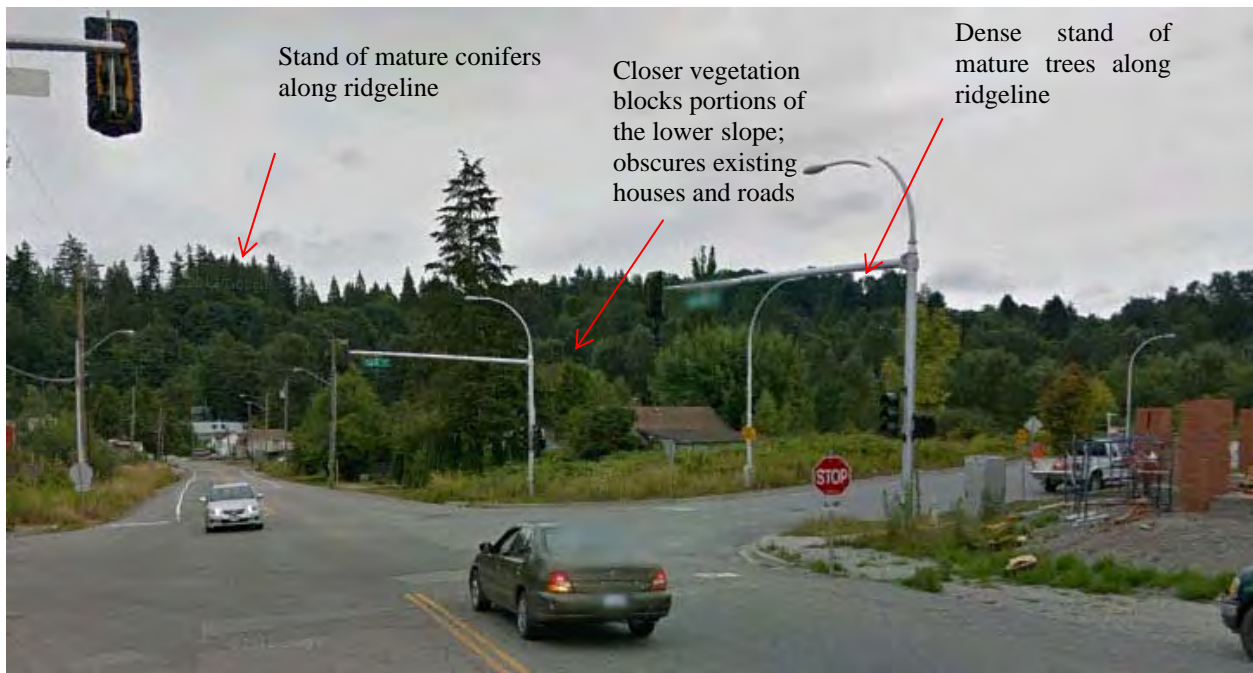
Old Yale Road at 124<sup>th</sup> Street – looking southeast

The loss of any of the tall tree stands would be most conspicuous from the closer views of the ICP area from the adjacent relatively flat Scott Road area. While a close view does not afford the opportunity to distinguish the prominence of the forest slopes of the ICP area from surrounding neighbourhoods, removal of numerous large trees in one area would be the far more noticeable than from distant views.

Of the three viewed zones, the primary concern based on this initial view assessment is the Pattullo Bridge and SkyTrain views. As previously stated, maintaining the ridgeline is important for the long views and retention of as many mature trees along the western and northern slopes as possible will likely mitigate the clearing within the flatter portions of the interior neighbourhood. It should also be noted that retention of clusters or individual mature trees, both evergreens and deciduous native species, within each lot will contribute to maintaining the overall character of the neighbourhood as viewed within the ICP area.

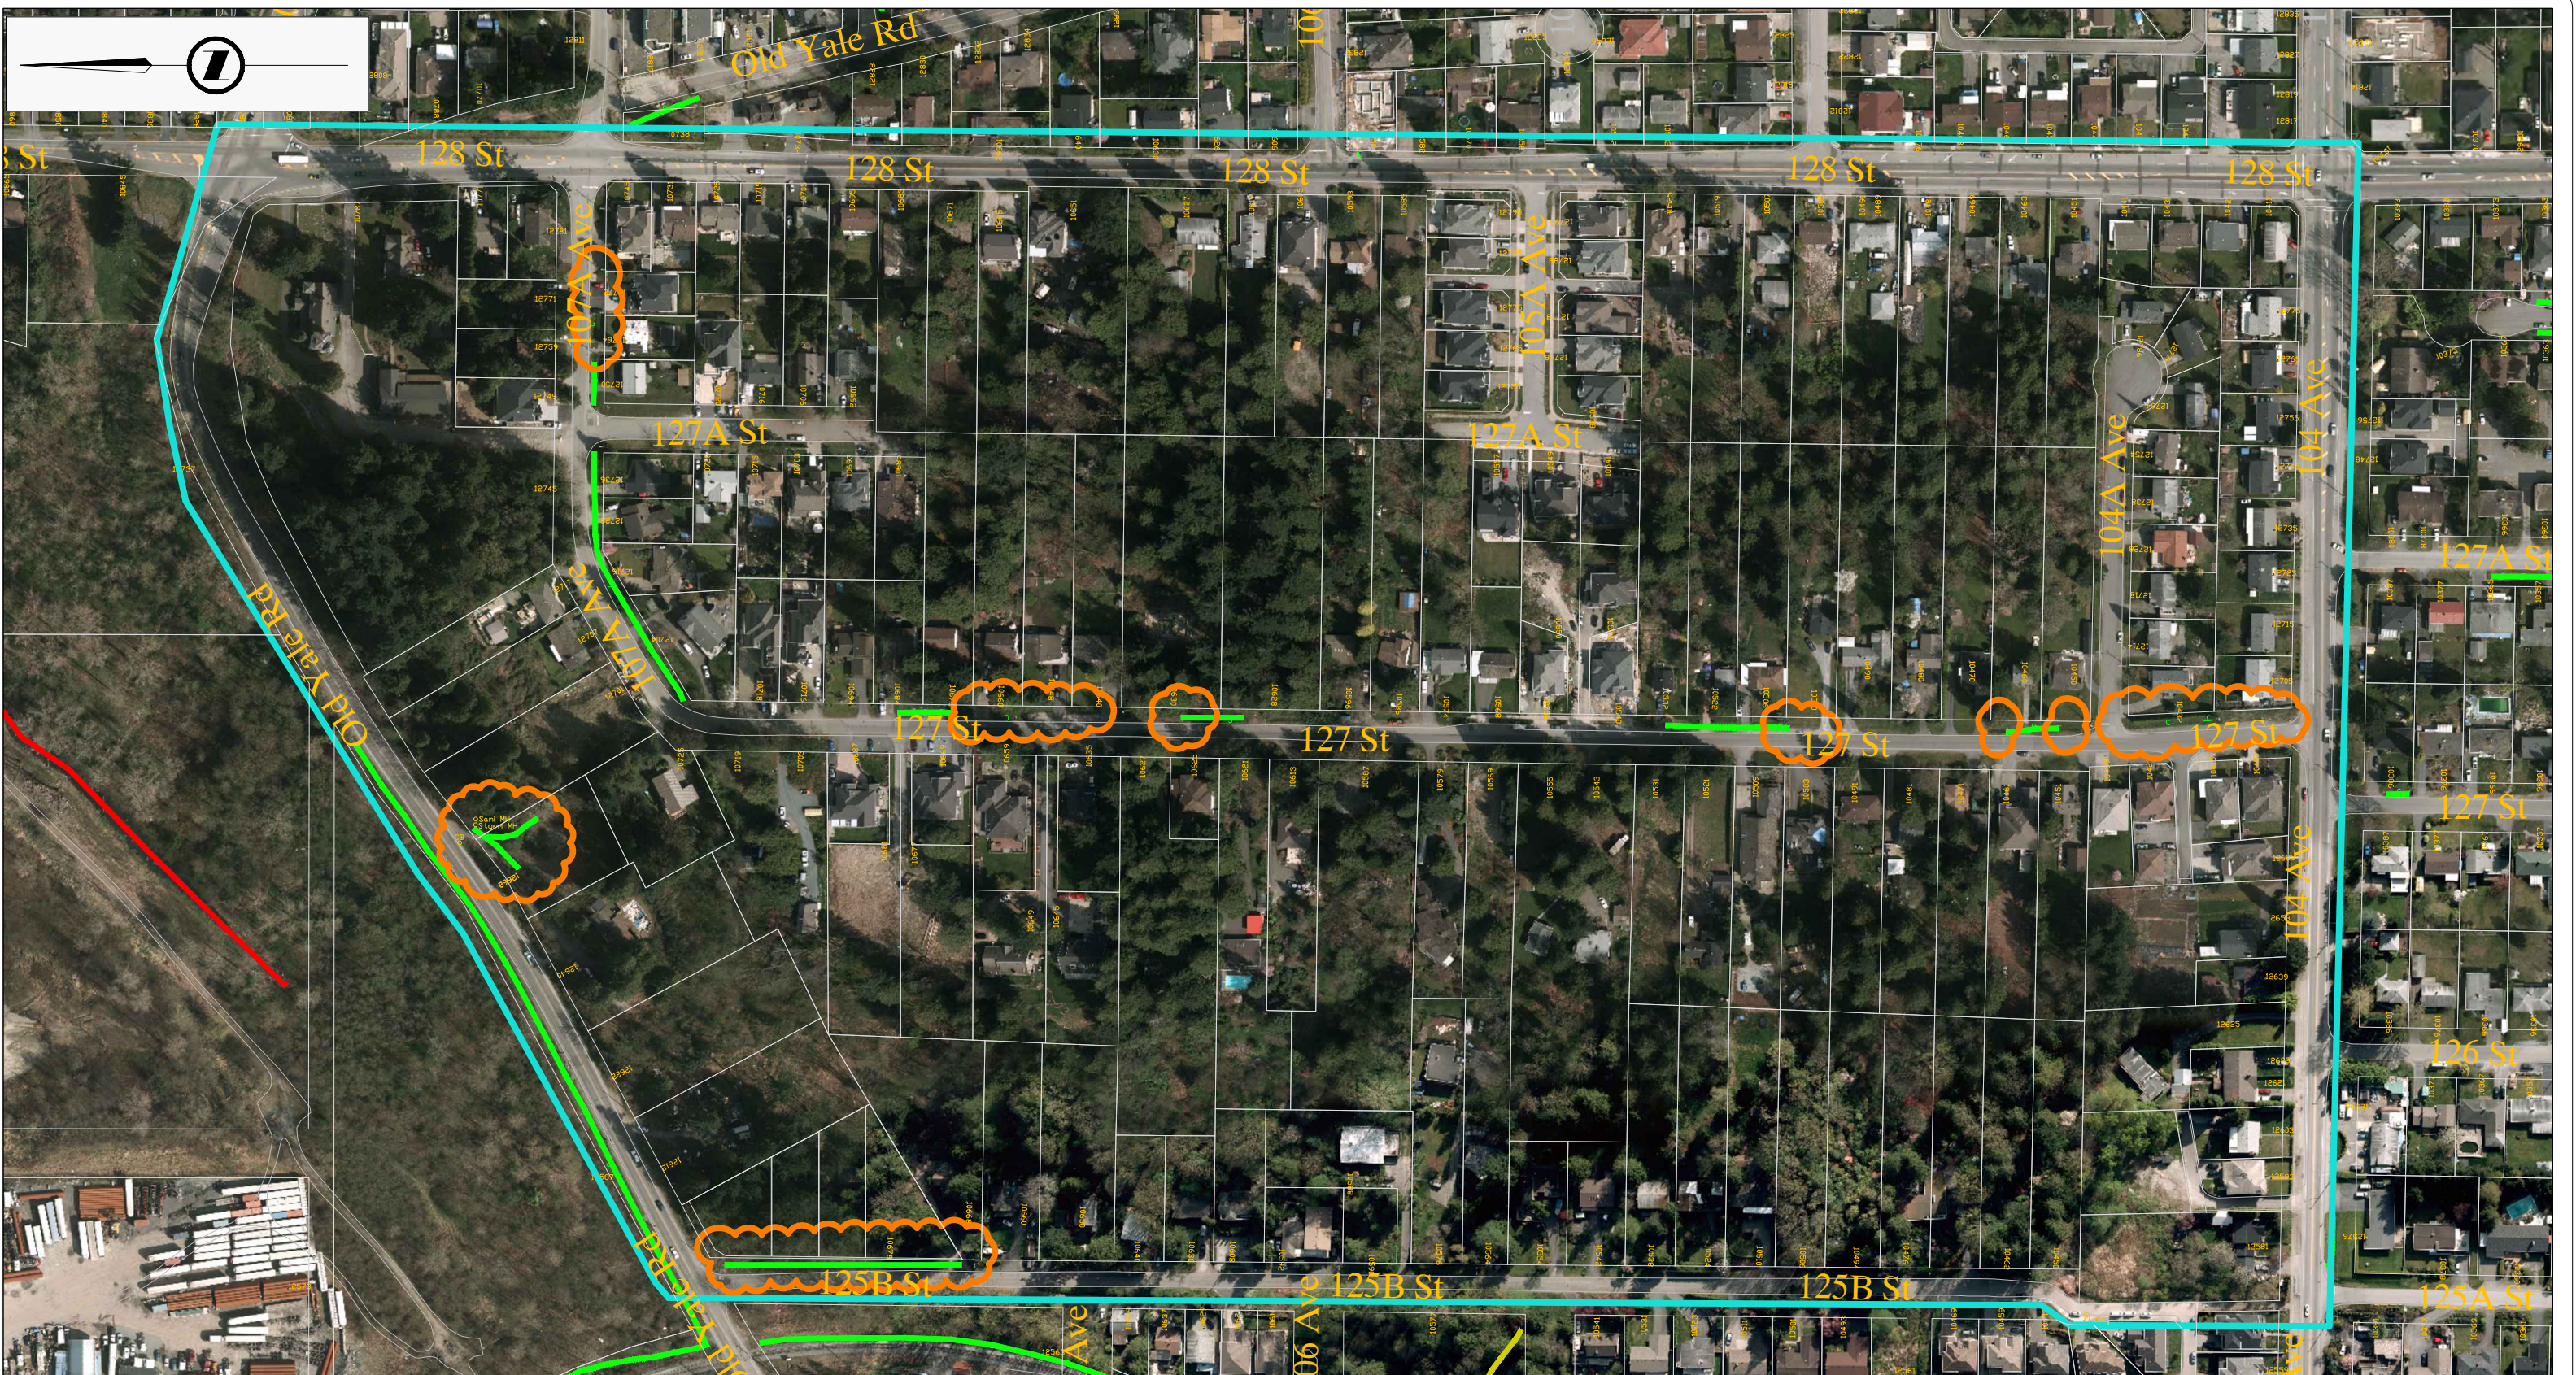
All of the watercourses within the Northwest Whalley ICP Study Area are currently shown on the City's online mapping facility (COSMOS) as Class C watercourses (green-coded). Phoenix has observed each of the watercourses within Study Area for this Environmental Study, and has determined that these watercourses are Class C (i.e. not fish habitats). There have not been any other aquatic habitats (e.g. ponds, wetlands) found in the Study Area. The Watercourse Update Map for this assessment is presented in Appendix A, Figure 2.

During the field assessment, Phoenix noted a number of minor COSMOS watercourse mapping inaccuracies, and Figure 2 shows the current watercourse locations and areas where changes have been determined by the field assessment for this Environmental Study. For example, watercourses shown on COSMOS along 127<sup>th</sup> St. and 107A Ave. have been enclosed in storm sewers. There is also a previously unmapped Class C watercourse on 125B St. near the intersection with Old Yale Road, and two short Class C watercourses near the base of the slope at 12662 Old Yale Road.

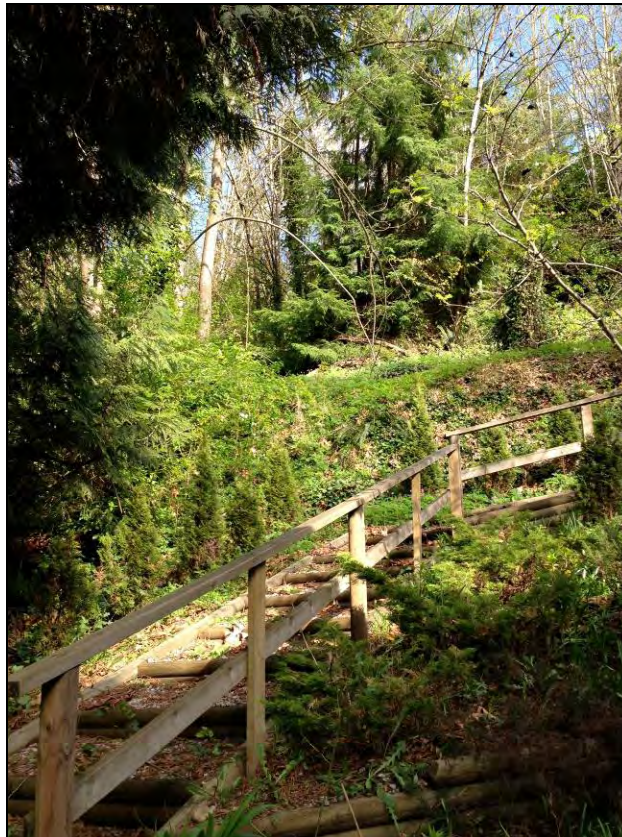
**Photo 2:** Very steep forested slope at 10592 125B Street.

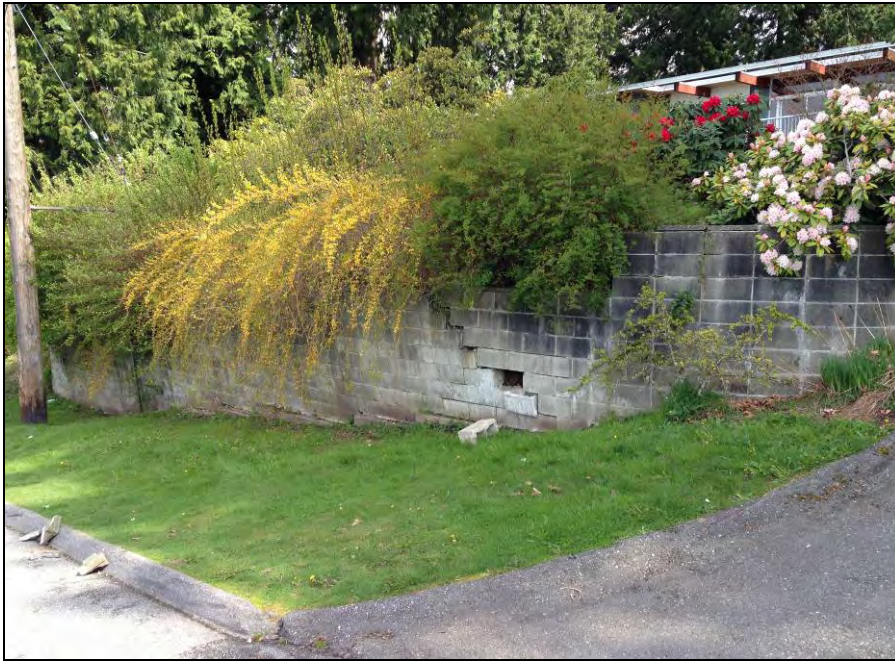
Indications of soil movement in landscaped areas along steep slopes of the Study Area also have been observed. Where soil has been excavated and re-graded for residential development, the deposited soil and imported topsoil can slowly move over the undisturbed, more consolidated native till soils. Examples of soil creep from these activities have been observed with cracked and collapsing retaining walls along 125B St. (Notes 1 & 2, Figure 4, Photo 3).

**Photo 3:** Retaining wall failure along 125B Street.

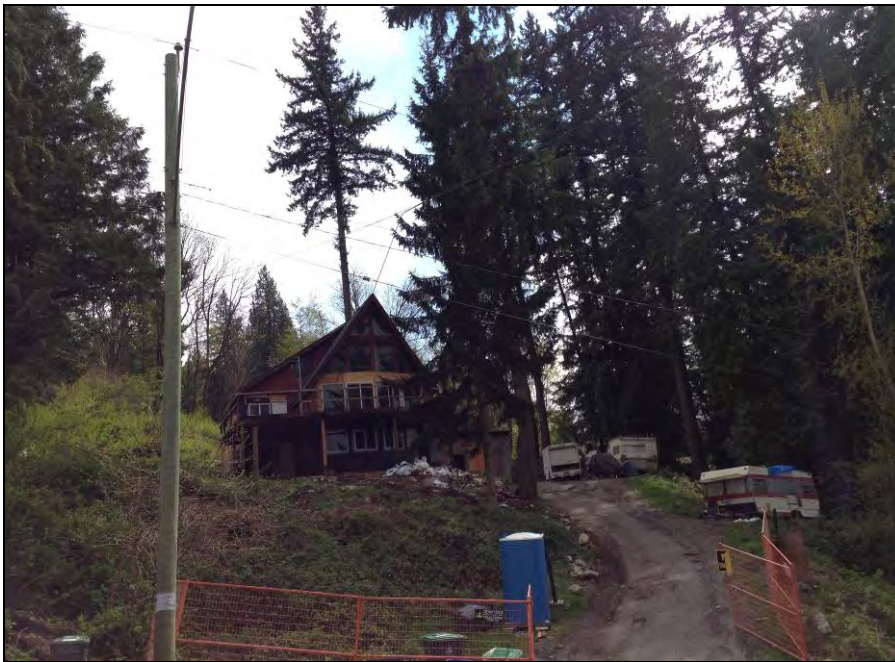
**Photo 4:** House under construction at 12512 Old Yale Road.

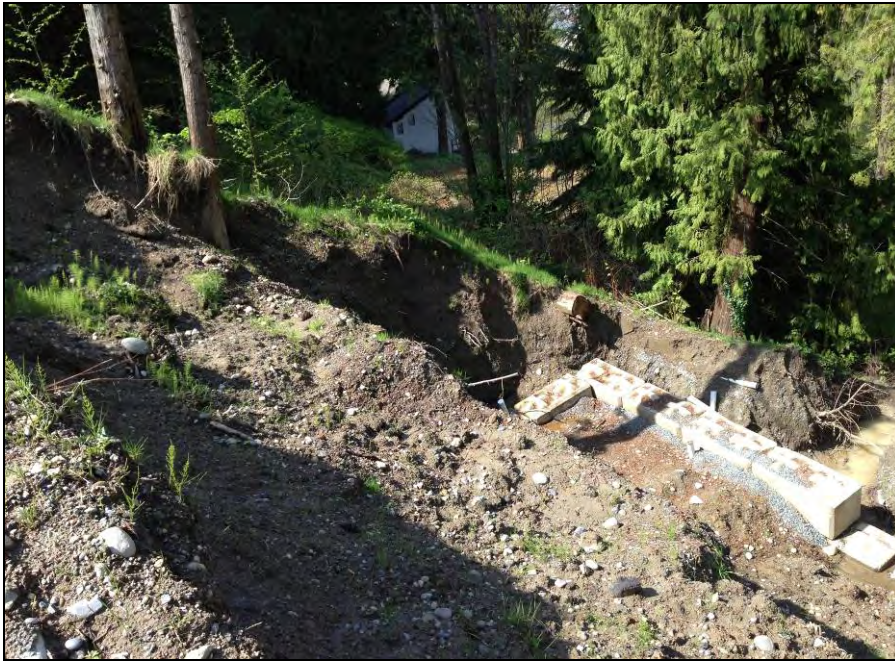
**Photo 5:** Excavations on steep slope for re-developments at 12701 – 107A Avenue.

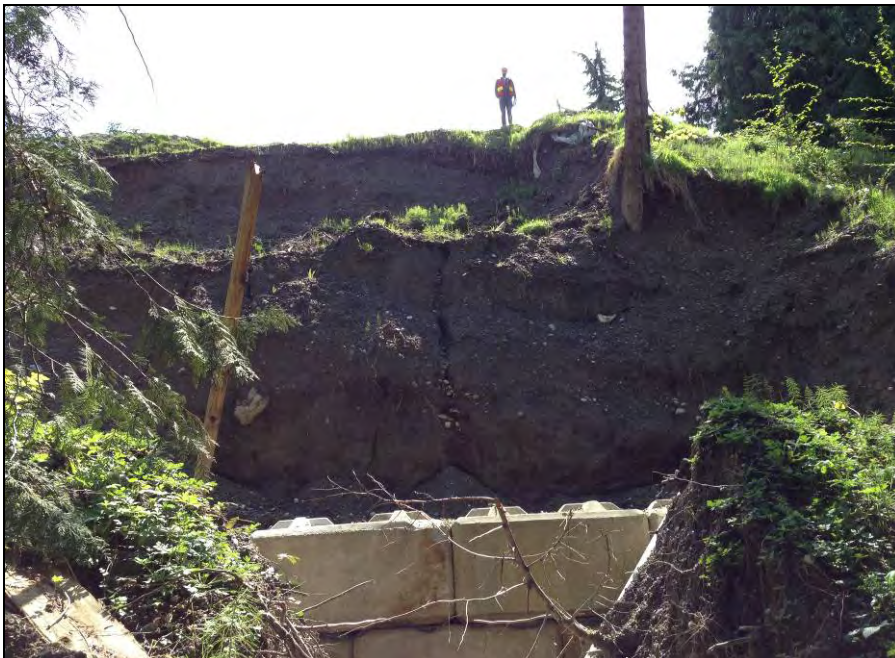
**Photo 6:** Slope failure risk from steeply excavated fill and native soil with evident erosion.

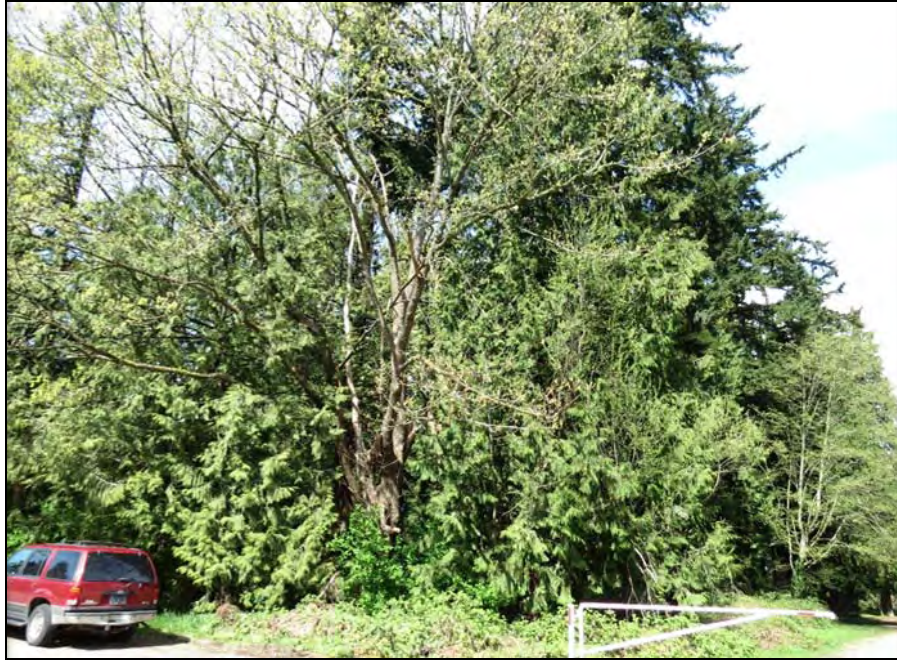
**Photo 7:** Typical forest composition of the forested block situated west of St. Helen's Anglican Church (April 12, 2013)

The Forested Blocks Vegetation Type was associated with many of the back yards and vacant sites within the Study Area. Most forested areas were conifer dominated with western red cedar (*Thuja plicata*), Douglas-fir (*Pseudotsuga menziesii*) and western hemlock (*Tsuga heterophylla*) commonly encountered. Patches of deciduous trees were also observed including red alder (*Alnus rubra*), bigleaf maple (*Acer macrophyllum*) and paper birch (*Betula papyrifera*). The understory was composed generally of sparse to moderate (5 - 50%) cover of shrubs including salmonberry, vine maple (*Acer circinatum*) and red huckleberry (*Vaccinium parvifolium*). Sword fern typically dominated the herb layer. Less disturbed areas were observed west of St. Helen's Anglican Church while the understory of forested blocks within residential backyards were heavily modified. (Photos 7 – 9, Appendix B).

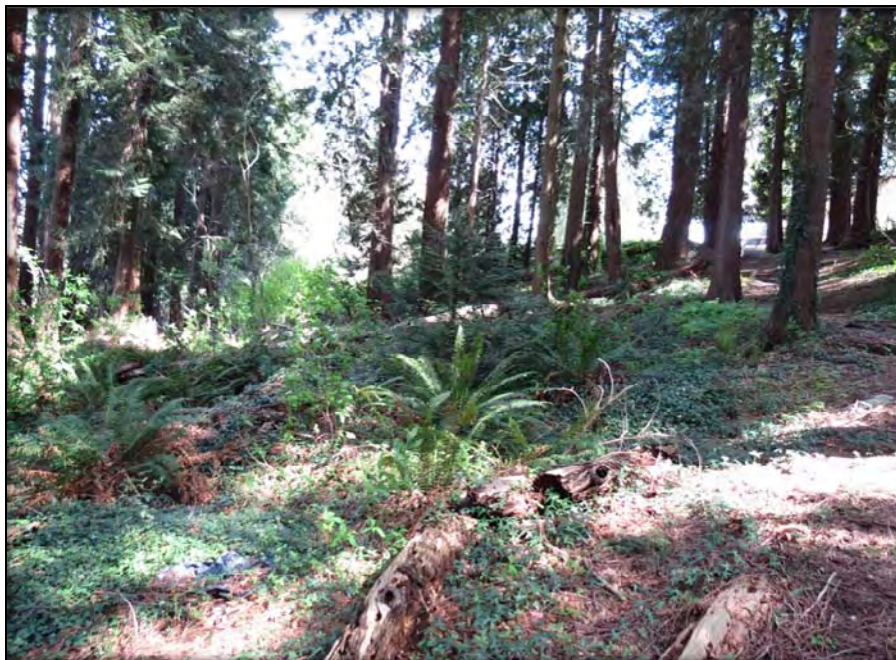
**Photo 8:** Typical understory vegetation composition of the forested block situated west of St. Helen's Anglican Church (April 12, 2013).

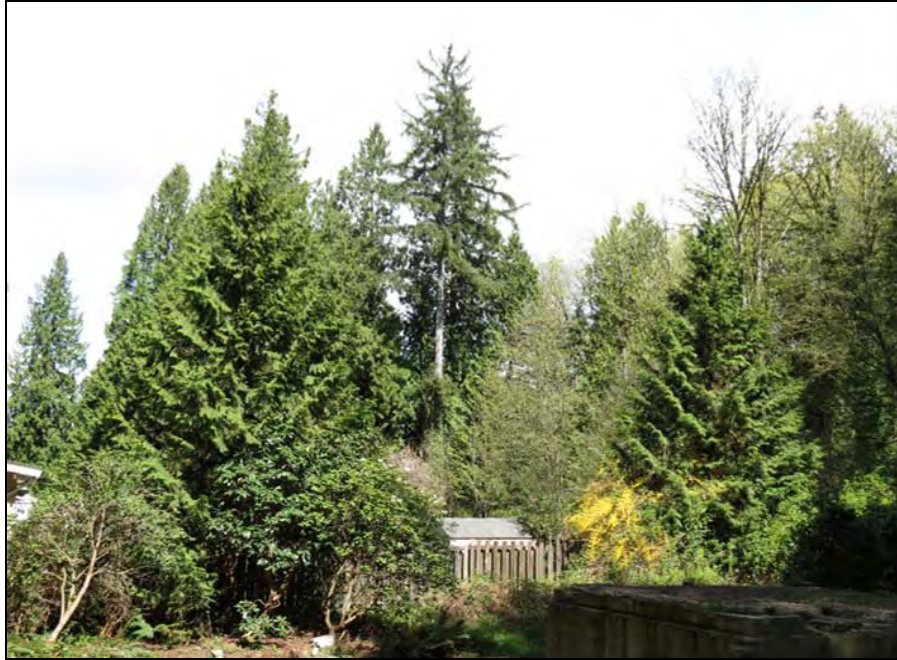
**Photo 9:** Typical backyard vegetation beneath forested blocks observed within residential backyards (April 12, 2013).

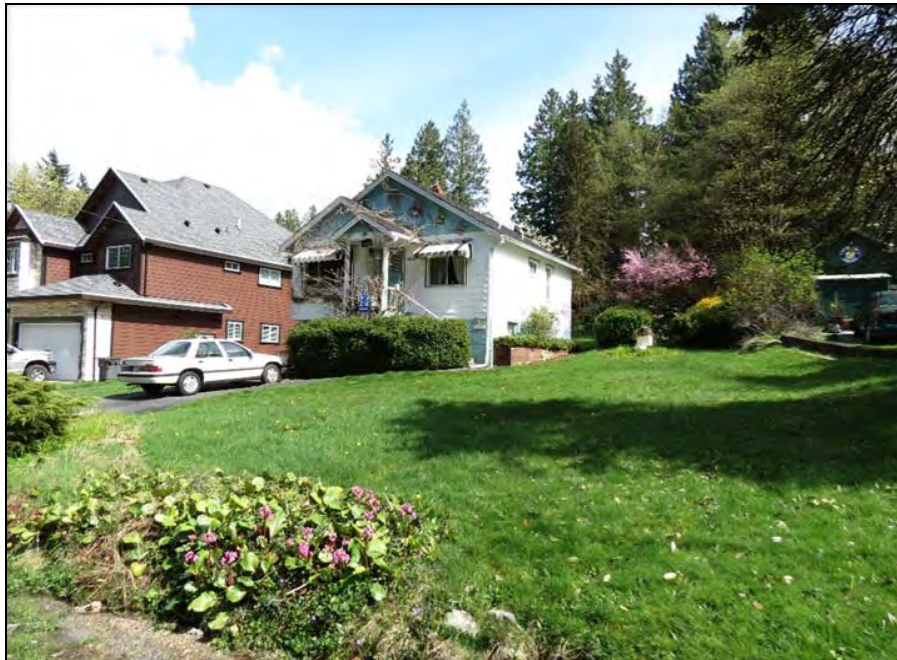
**Photo 10:** Existing residential area with maintained lawn and ornamental vegetation observed within the Northwest Whalley ICP Area (April 12, 2013).

The Residential Vegetation Type was situated mainly along the frontages of all streets within the Study Area. The vegetation within these locations were dominated by maintained grass lawns and ornamental vegetation (Photo 10). Much of the vegetation of the residences along Old Yale Road were dominated mainly by invasive species such as Himalayan blackberry (Photo 12).

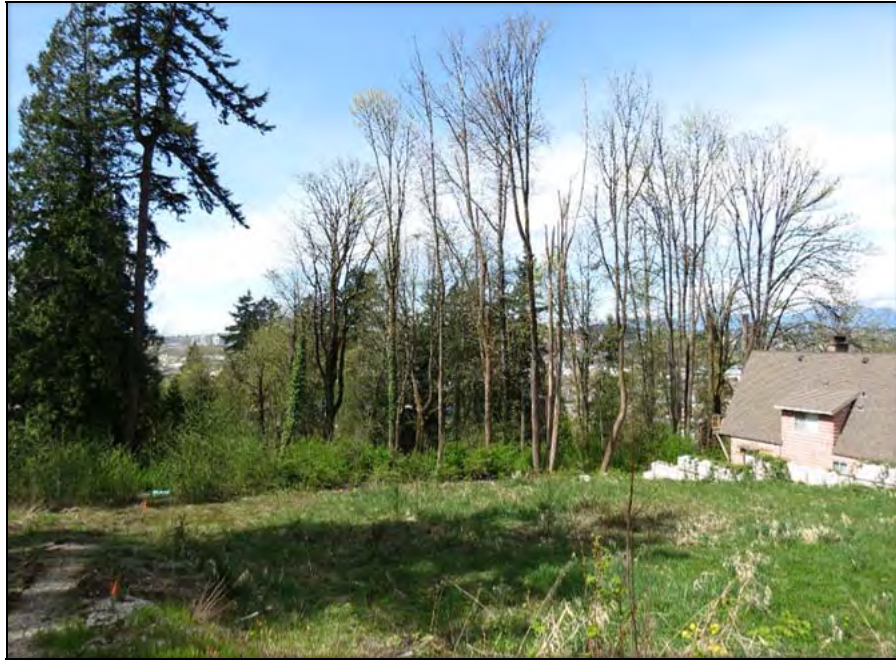
**Photo 11:** Recently cleared lot (10681 127th St.) observed within the residential area of the Northwest Whalley Infill Area. A coyote was also observed traveling along the forested interface of this site (April 12, 2013).

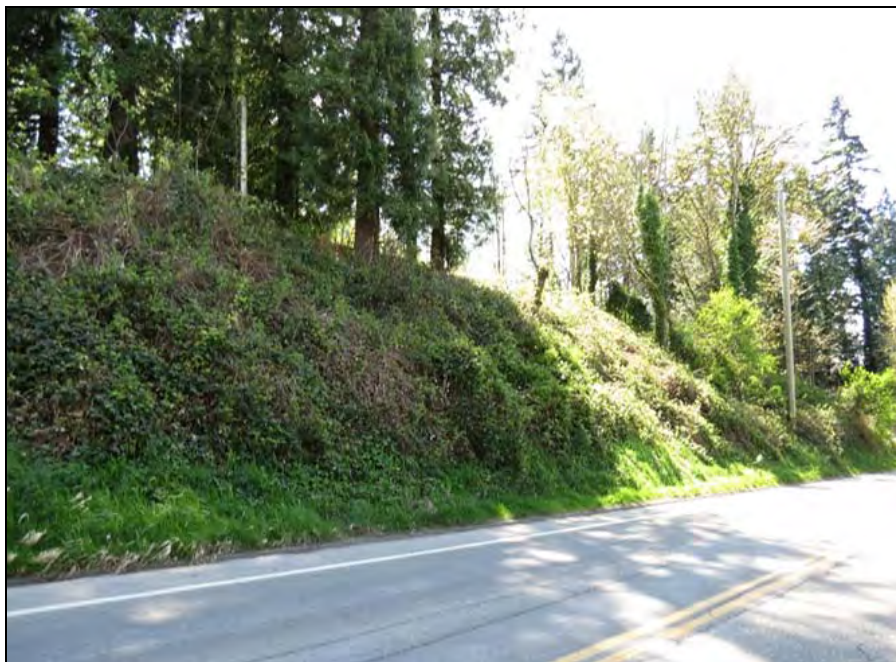
**Photo 12:** Invasive species that dominated the frontages of many of the residential properties along Old Yale Road (April 12, 2013).

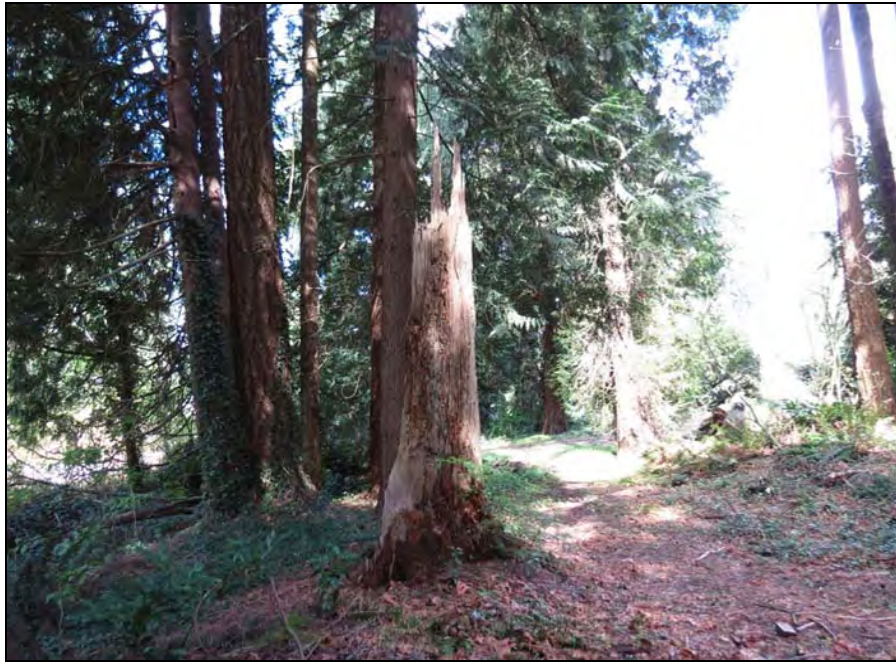
**Photo 13:** Class 8 wildlife tree observed at the vacant lot on 127th Street (April 12, 2013).

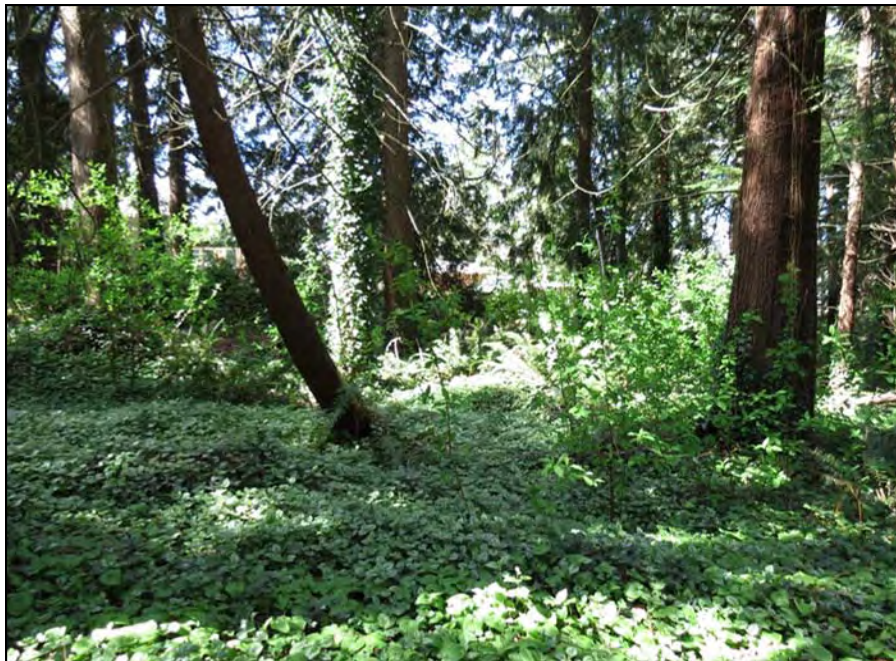
**Photo 14:** Invasive English ivy on the ground and on mature trees observed within the forested block situated to the west of the St. Helen's Anglican Church (April 12, 2013).

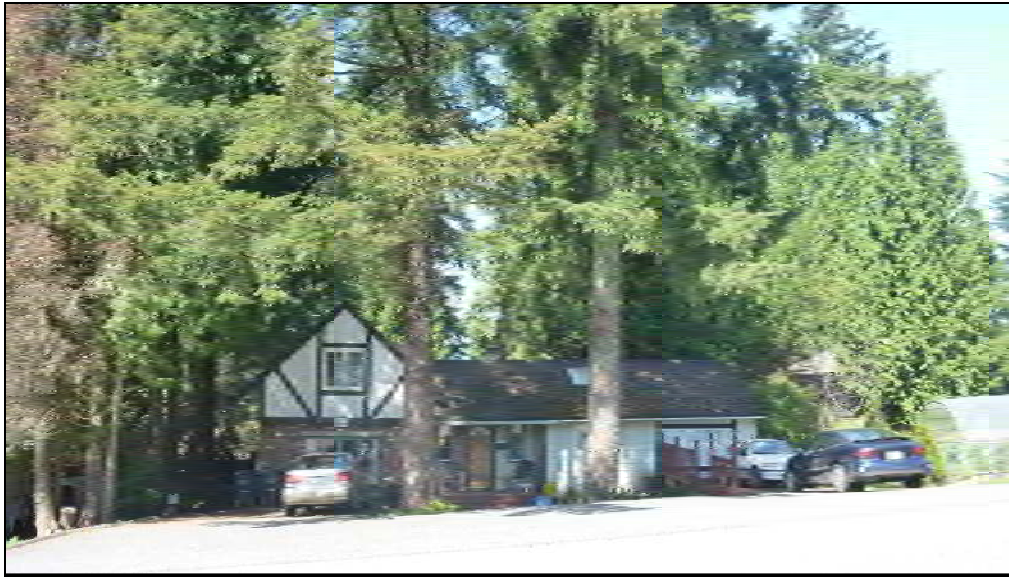
**Photo 15:** An older house with existing trees incorporated into the site plan

The assessment of arboricultural values in the ICP Study Area has been based on several field observations in April and May 2013, as well as aerial photo interpretation, to identify and map tree stand characteristics and individual trees of high value. Although extensively developed for residential properties, it is estimated that about one half of the Study Area is presently forested with native trees; many of which are over 100 years old. In general terms, native tree species dominate the forested areas and introduced species dominate in the developed areas. There are also many larger lots where development has incorporated both native and introduced species (Photos 15 & 16).

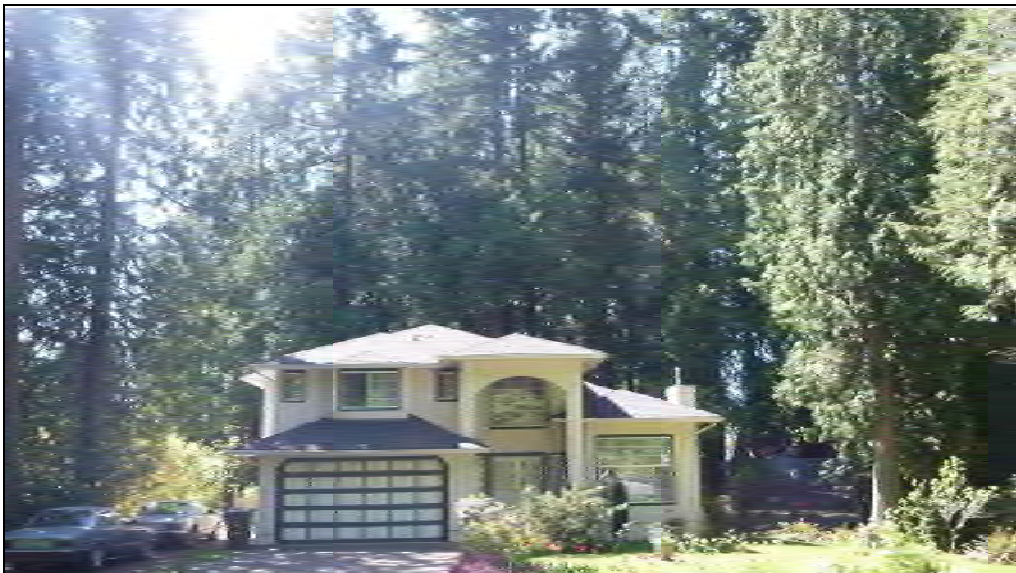
**Photo 16:** A newer house developed with the existing trees

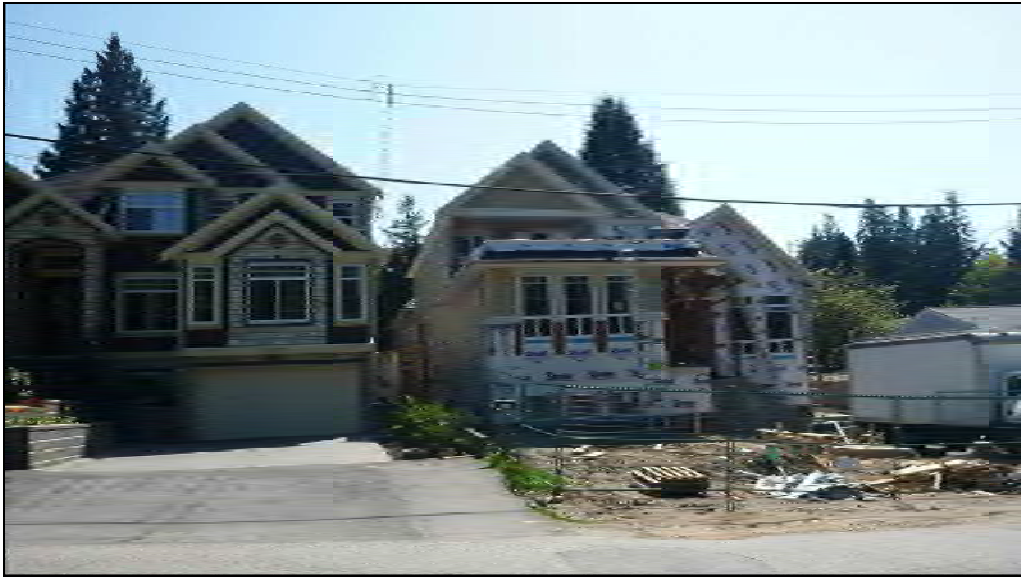
**Photo 17:** Newer homes developed with no trees retained

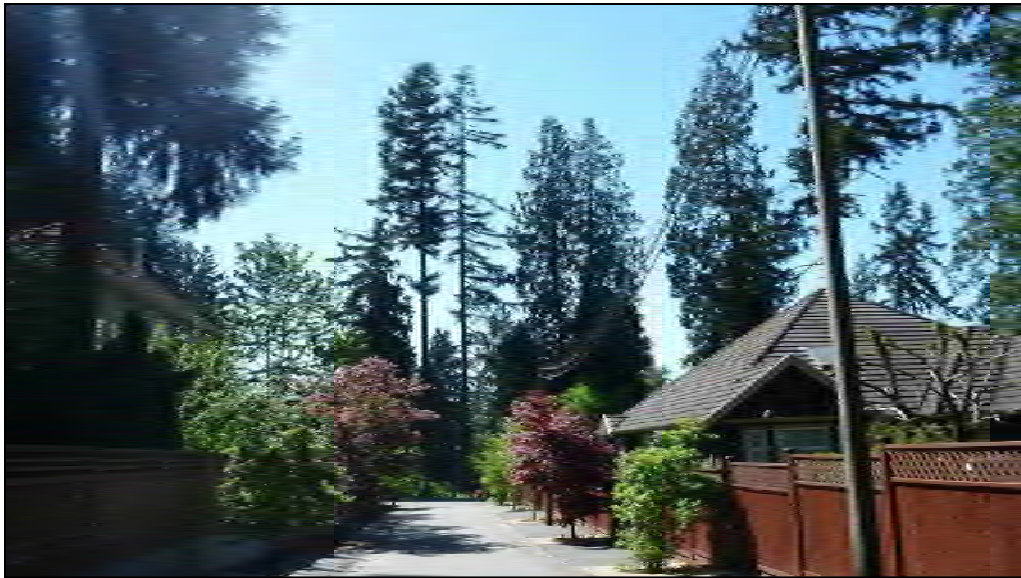
**Photo 18:** View showing declining condition of trees retained within a recent panhandle infill project

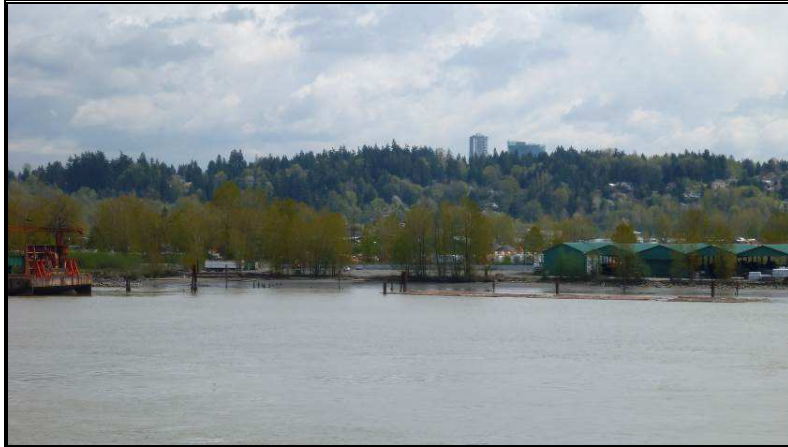
Overview of the subject area as seen from the New Westminster side of the Fraser River.

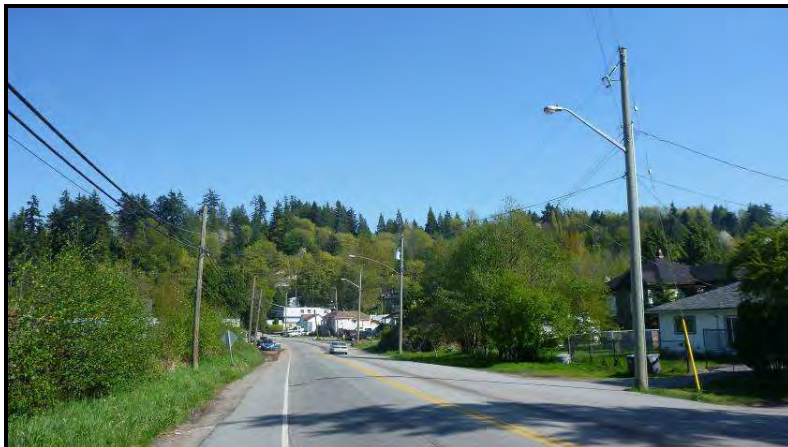
View of the western slope looking east from the base of Old Yale Road.

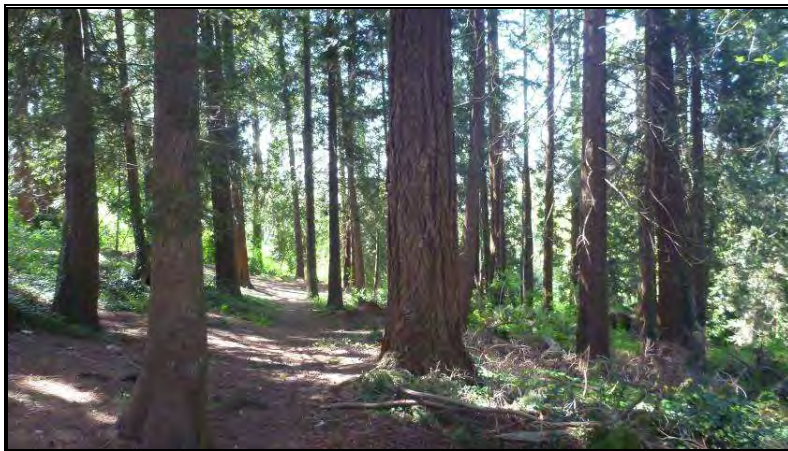
View showing the forest conditions to the rear of St Helens church.

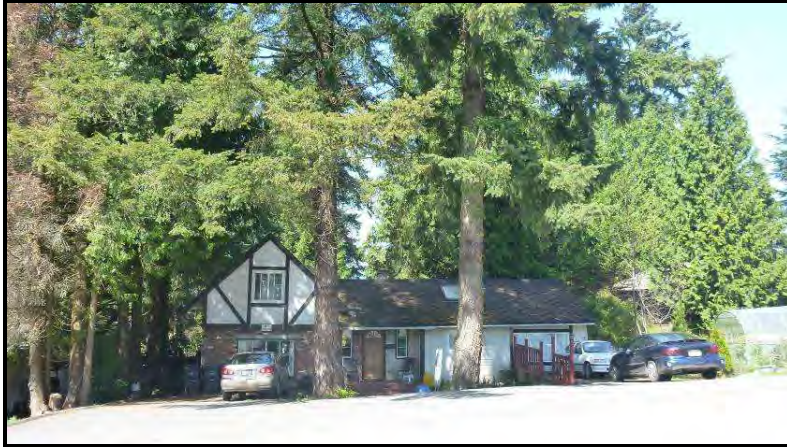
Example of an older home with existing trees incorporated into the site plan.

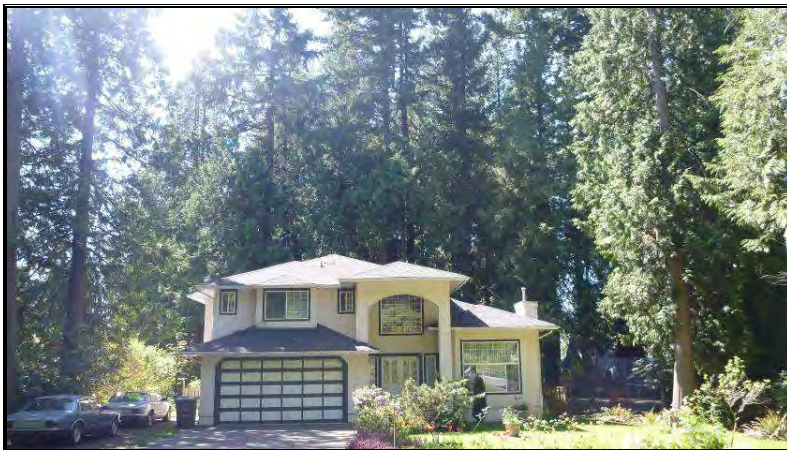
Example of a newer home developed within the existing trees.

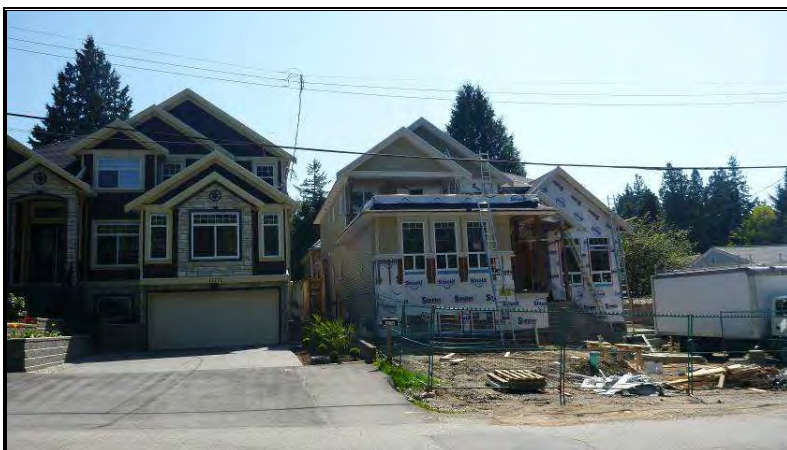
Example of newer homes developed with no trees retained.

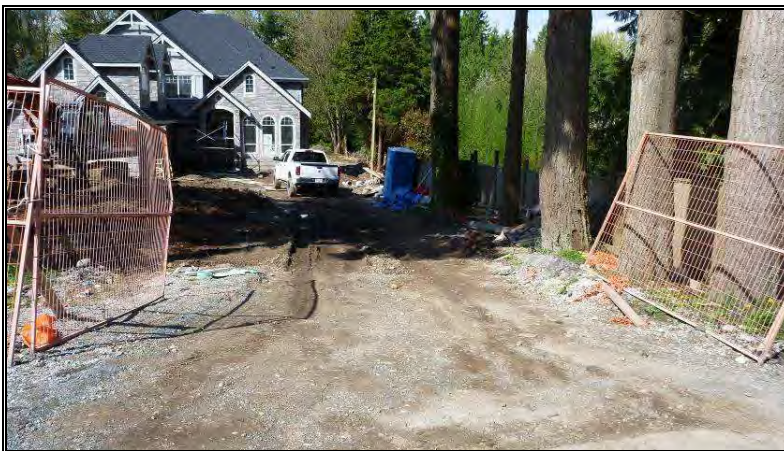
- **Development / Construction Impact:** Where new development has occurred without adequate tree protection, decline and death has resulted. There are a number of lots throughout the study area where tree protection has not been adequate to protect the trees that have apparently been designated to be retained.

Development in progress at 10521 - 127<sup>th</sup> Street.

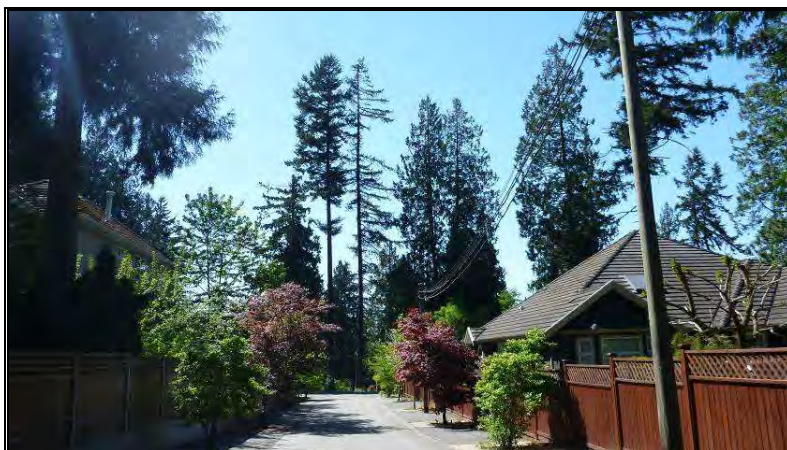
At the relative recent infill development at 10645 & 10649, selective trees have been retained in relative close proximity to the new homes. We cannot confirm if or to what extent development activity impacted the trees, however, there is visible decline in a number of the retained trees, such that we can expect that several trees will likely decline and require removal in the relative near future.

View showing the declining condition of trees retained within recent infill projects.

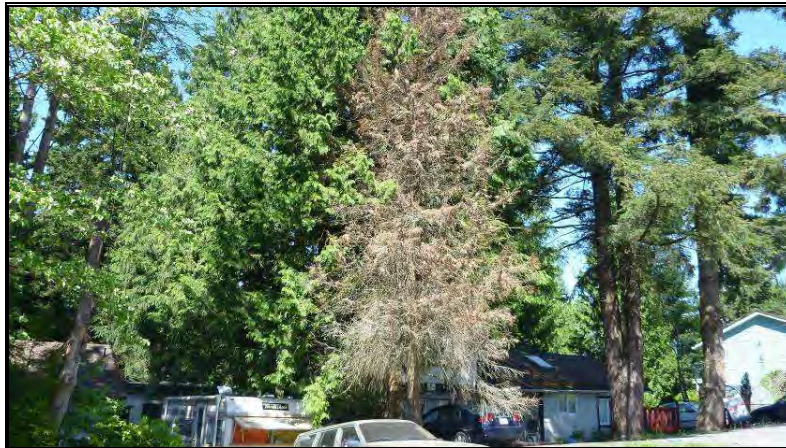
- **Disease and insect problems:** Overall, the extent of disease and insect problems within the study area is quite minor. We observed two problems,
  - There is a dead Lawson Cypress located in the front yard of 12759 - 107A Ave. The symptoms suggest that this tree has succumbed to the Pytopthera root disease (P laterallis) that is very

common to this species. The extent of the problem is not considered to be significant due to the fact that there are only a few Lawson Cypress within the inventory of ICPA trees.

Dead Lawson Cypress  
in front of 12759 –  
107A Ave.

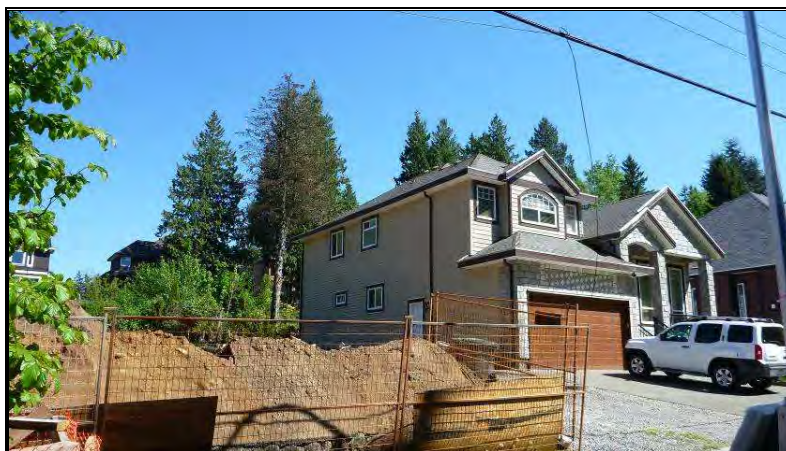
- There was one other dead Lawson Cypress within the study area in the rear yard of 10556 – 127<sup>th</sup> Street. It is difficult to determine if this tree was infected by *P lateralis* or if construction associated with the new home on this lot was the cause. It has been established that construction impact can result in increased susceptibility of Lawson Cypress to this disease.

Dead Lawson Cypress  
in the rear yard of  
10556 – 127<sup>th</sup> Street.
