# ENVIRONMENTAL STUDY REPORT

Northwest Whalley Infill Concept Plan Area  
Surrey, B.C.

City of Surrey  
Community Planning Division  
Planning & Development Services

PHOENIX ENVIRONMENTAL SERVICES LTD.

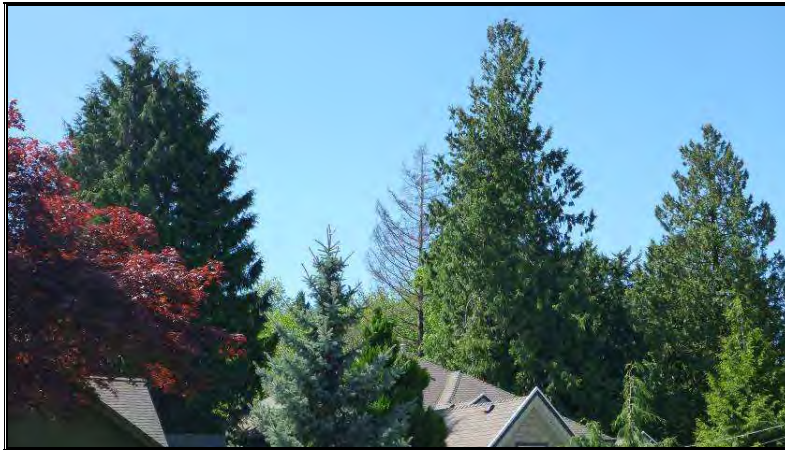
- We observed one dead Douglas Fir and another Fir that is under stress and in decline. The dead tree is located to the rear of 10471 – 127<sup>th</sup> Street. The dead tree is located within a forested area where no recent disturbance has occurred. Visual evidence suggests that the tree has died due to Douglas Fir Bark Beetle infestation. This problem is not common in Surrey but it does occur from time to time. A tree under aggressive attack from this beetle will defoliate within a matter of several weeks. Typically a healthy Douglas Fir will survive the attack, but in some cases, the trees do not recover.

View showing the dead Fir in the rear yard of 10471 – 127<sup>th</sup> Street.

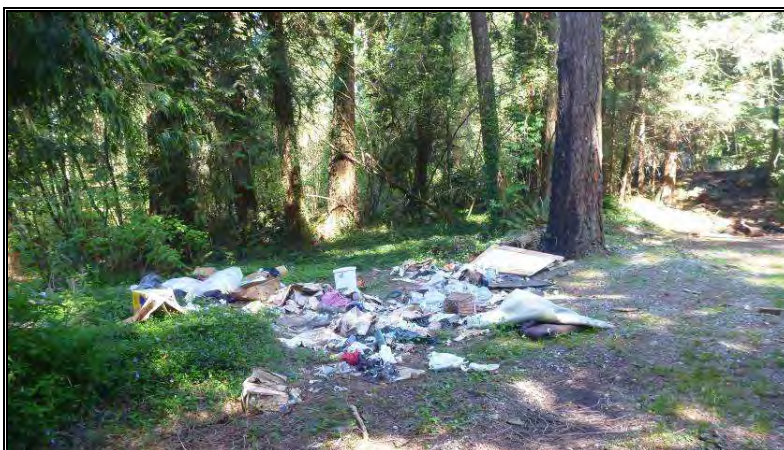
- **Invasive plants:** The ICPA is not dissimilar to many areas of Surrey where invasive plant species have become a problem. English Ivy, Lamium, Vinca, Blackberry and Knotweed were all found to varying degrees within the forested areas. The only invasive with potential to harm trees is the English Ivy. Removal and eradication of the ivy should be encouraged whenever possible.

Illustration of problems, disposal of garbage within forested areas, fire damage and invasive plant species.

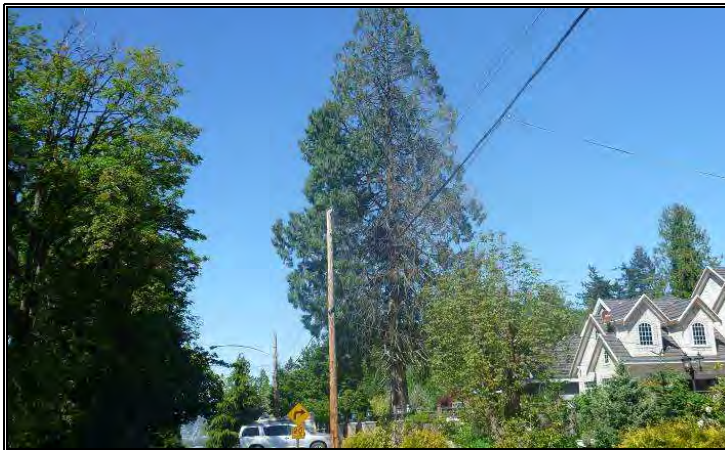
- **Inappropriate Tree Retention:** Not all trees are suitable for preservation in the context of residential development. In Surrey, the retention of trees is strongly promoted by city staff and in some situations this can result in the preservation of trees based solely on spatial consideration. We observed several trees that have been retained in conjunction with new development that quite simply should not have been retained. In the photo below, it is clear that the retained tree was removed from a previous forested situation where the condition of the foliage when exposed as a stand-alone tree was not fully considered. As a result, the retained tree is rather unattractive and potentially represent a risk to the residents due to dead limbs falling.
