South Westminster Integrated Stormwater Management Plan (ISMP)

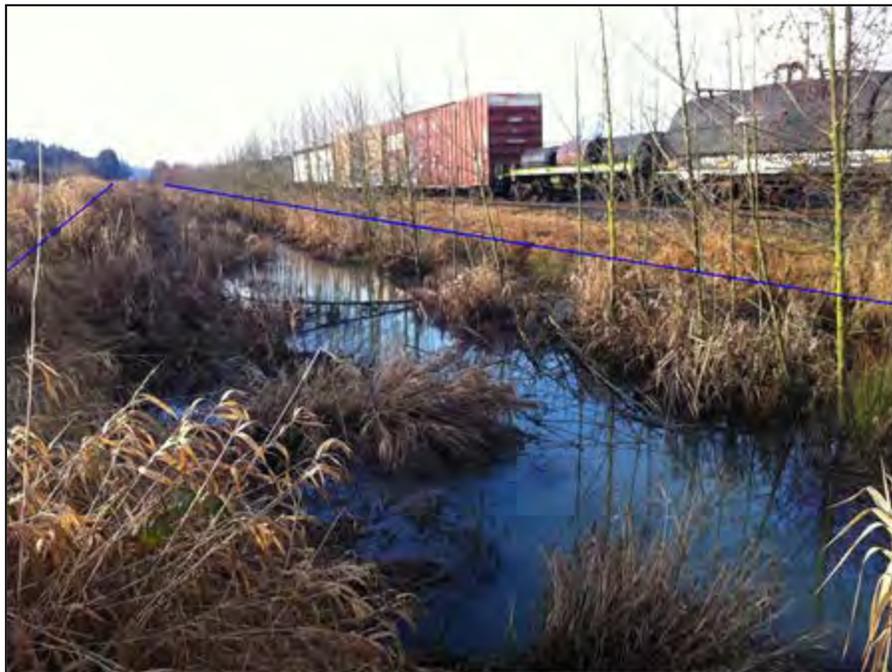
During a 5-year, 12 hour rainfall event, flooding is expected in the downstream half of Colliers Canal. Flood levels are expected to be just over 2 metres in elevation. The photo below shows Colliers Canal with the rough flooding elevation shown in blue.

Colliers Canal with approximate flood elevation during 5 year, 12 hour rainfall event.

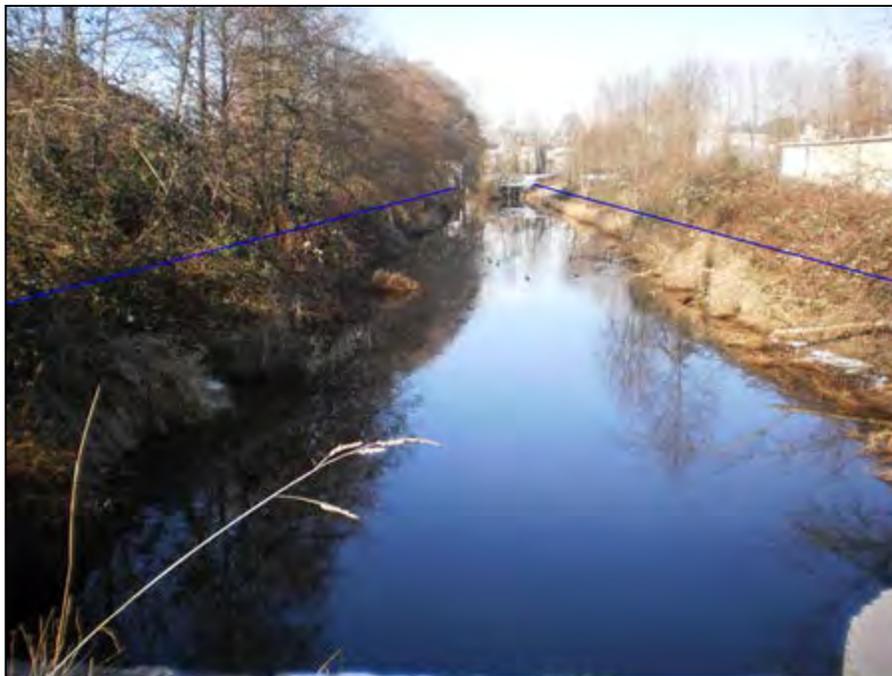
Increased surcharging is expected during a 5-year return period rainfall event. The elevation and extent of possible flooding is dependent on river level conditions during the event. The photo below shows Manson Canal with approximate expected elevations during a 5-year return period rainfall event during normal tide. It should be noted that the flood levels do not include freeboard so a flood level close to the top of bank may result in localized overtopping due to wave action.

Manson Canal with approximate flood elevation of a 5 year rainfall event during normal tide

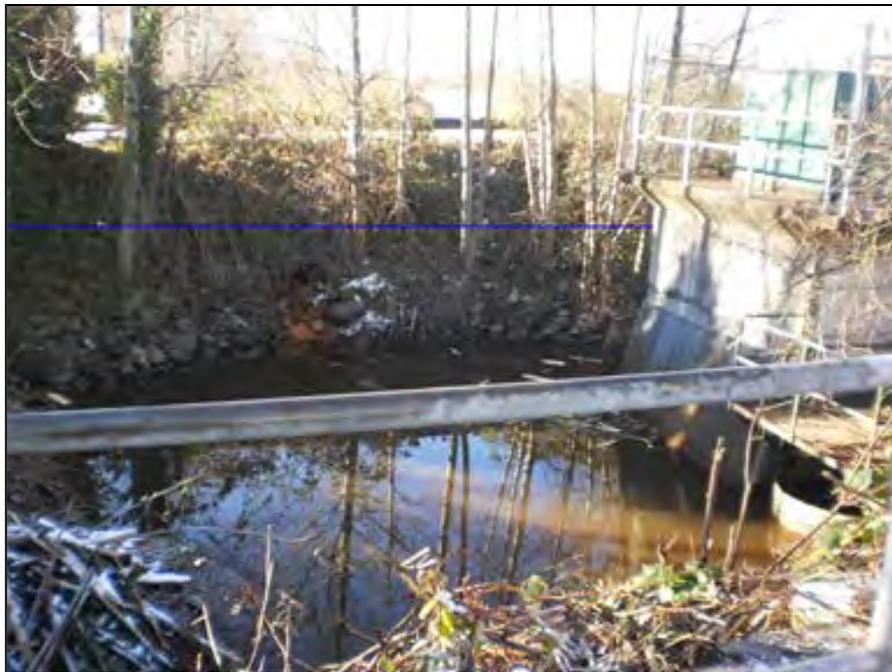
The photo below shows Old Yale Pump Station with approximate expected elevations during a 5-year return period rainfall event during normal tide.

Old Yale Pump Station with approximate flood elevation of a 5 year rainfall event.

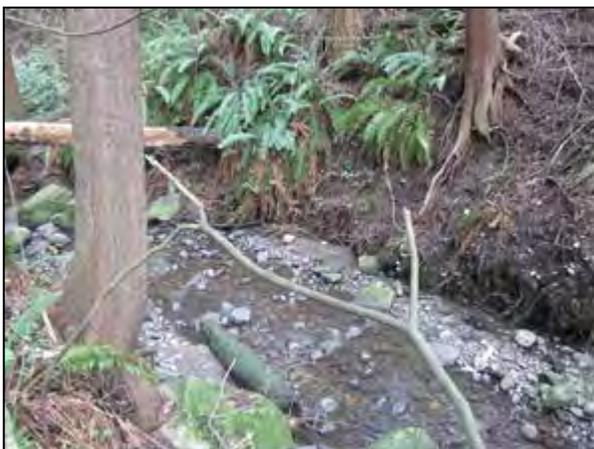
As an example, the photos below illustrate stream bank erosion found at Delta, Robson, Scott and Pattullo creeks.

Delta Creek: Evidence of erosion near 96A Avenue.

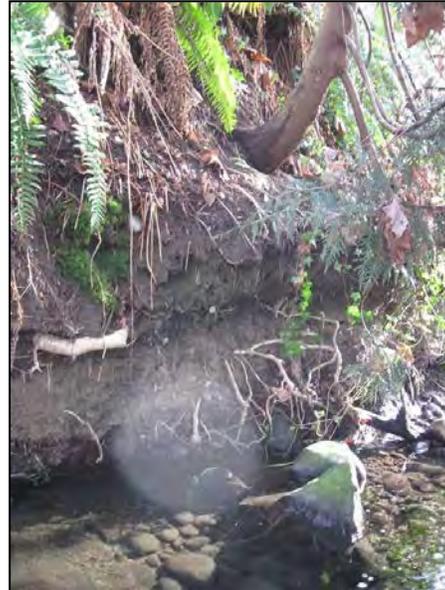
Pattullo Creek: Evidence of erosion near 100 Avenue near Home Depot

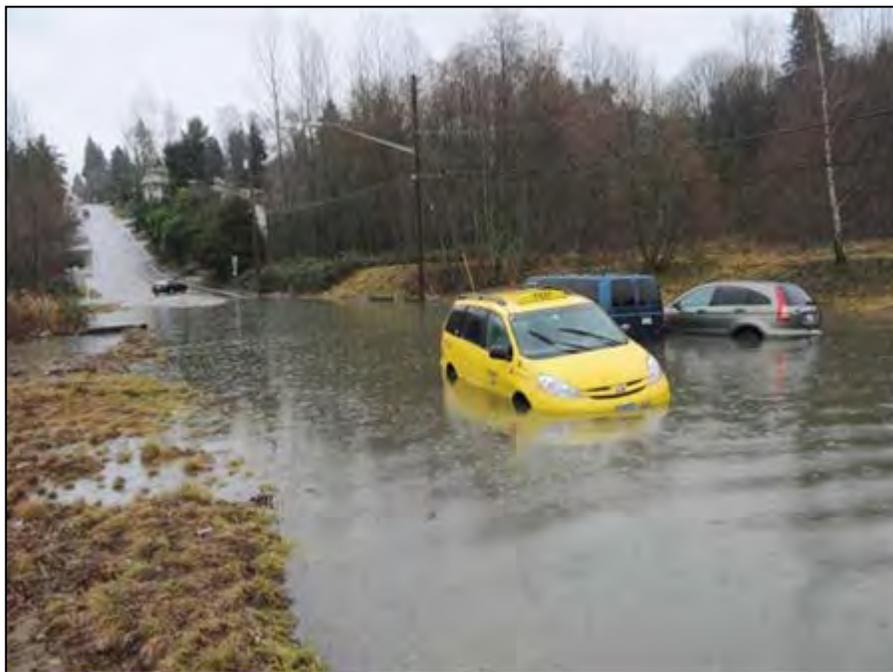
The intersection of 111 Avenue and 128 Street was flooded on the morning of January 11, 2014. The flooding was the result of a 1 in 6 year return period rainfall. **Photo 1** shows the extent of flooding at the intersection of 111 Avenue and 128 Street during the morning of January 11.

111 Avenue Looking East, at 128 Street (Jan 2014 Storm)
